Final report

TISO 35+

Thirty-five years with the TISO-10 PV plant: a statistical analysis of failure modes and their impact on safety and production

Date: 19th November 2018

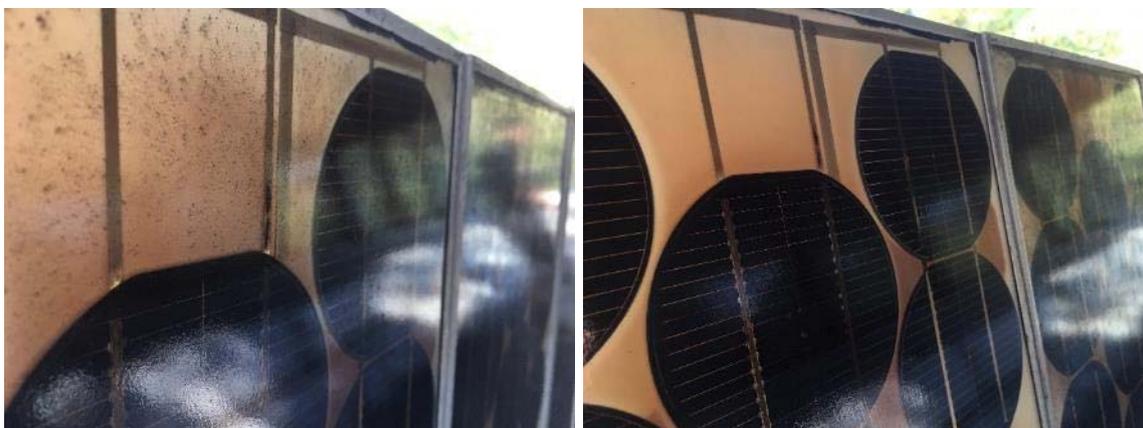
Figure 1: ARCO Solar Module before/after the cleaning: negligible effect on performances.

As it can be seen from the pictures, the conditions of the modules were critical for the detachment of the Tedlar back foil and for the severe darkening of most of them. The modules were then placed under a roofed area to grant an easy accessibility to the mobile flasher.

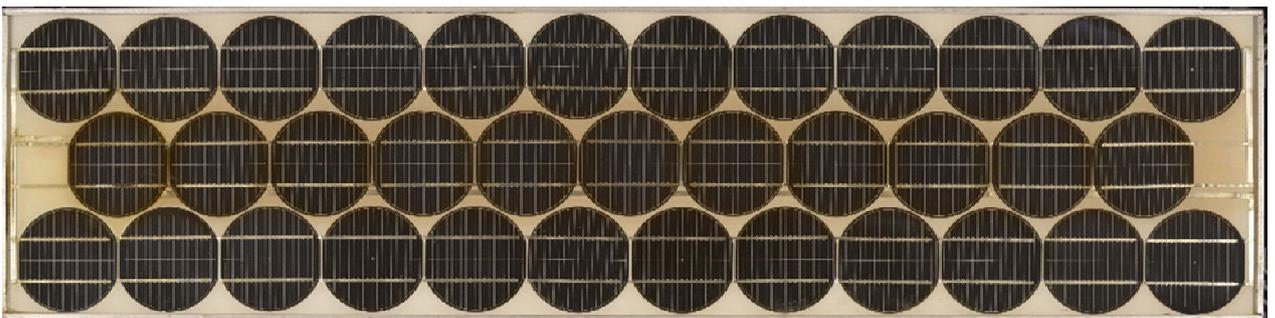
Figure 5: Class B module: central cells' row partial yellowing

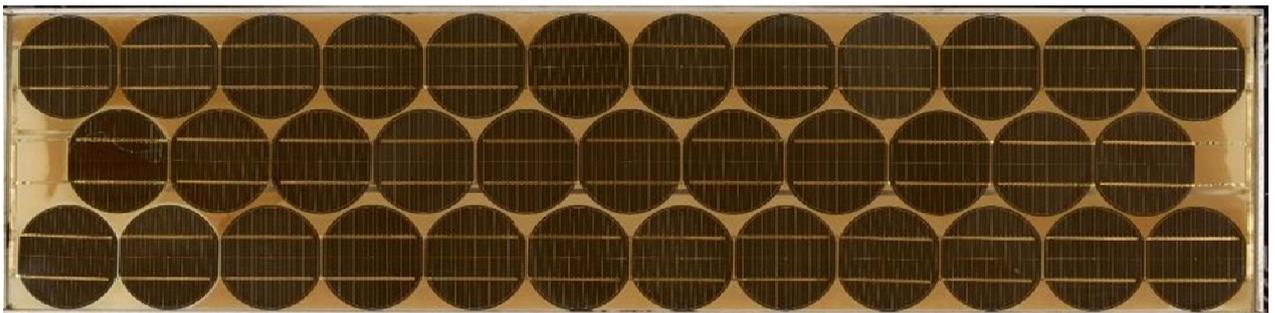
Figure 6: Class C module: complete yellowing

The impact of the discoloration extent is clear in Figure 1, where modules in Class C (uniform browning) show on average the strongest power loss (-26.1% with respect to the initial values). It is remarkable that modules in Class A (for which the encapsulant is still fully transparent) are still performing, in average, at 95.1% of their initial power after 35 years of operation, corresponding to an average degradation rate as small as 0.14%/y.

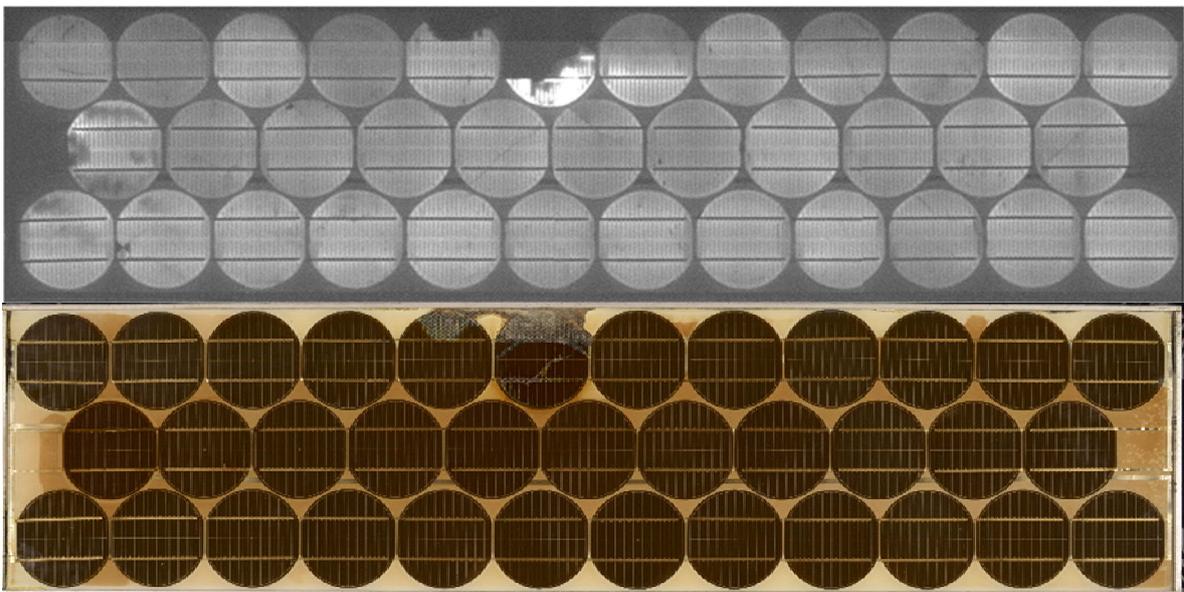
The first step consisted in the selection of modules with visible cracks and well recognisable defects, highlighted by drastic differences in the luminescence of the EL picture. Second step was the comparison of these areas in terms of browning, delamination, bubbles, due to the heating process behind the hot spot: this task was accomplished using 36 Mpixel high resolution images, shot in the dark room with controlled and reproducible light exposure. This process allowed to discriminate between different types of defects (cracking, delamination with moisture penetration, soldering defects, etc.) which were subsequently analysed through the IR images taken indoor, using a power supply to force current through the cells. In order to highlight gradually the temperature differences on the modules, the procedure described in the white paper “Review on Infrared and Electroluminescence Imaging for PV Field Applications” was applied: infrared shots were taken with a Fluke IR camera, with resolution of 320x200 pixel, at the beginning of current flow, after 20”, after 120” and after 4 minutes, once reached the thermal balance. Though the same patterns of the EL pictures were highlighted on severely damaged modules, the condition of the solar cell in front of the junction box was not clear: apparently, one of the most critical cells was only partially hot, even when important defects from the electroluminescence and visual inspection pictures were evident. To have a better understanding, it was decided to further check the same modules also in outdoor conditions, with IR analysis through direct current generation of the module, which was exposed in short circuit mode.

Figure 9: comparison of EL picture with visual inspection through high res image analysis

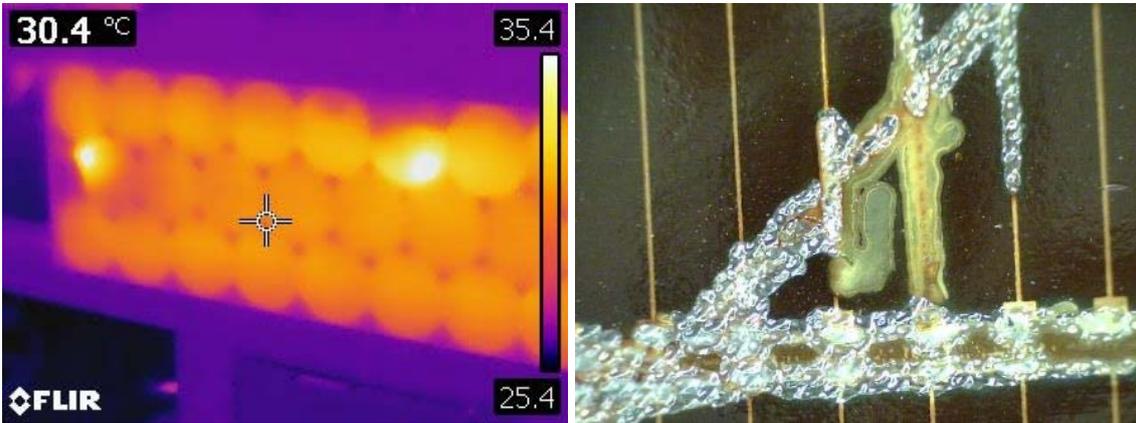
This analysis allowed to recognize 78 modules with critical hot spots (temperature difference $>20^{\circ}\text{C}$) and 110 modules with light hot spots ($10^{\circ}\text{C} < T < 20^{\circ}\text{C}$); 85 modules showed no sign of appreciable hot spot and 15 couldn't be inspected with the electroluminescence/IR test.

Figure 10: verification of EL results through indoor hot spot test, macro picture of hot spot area.

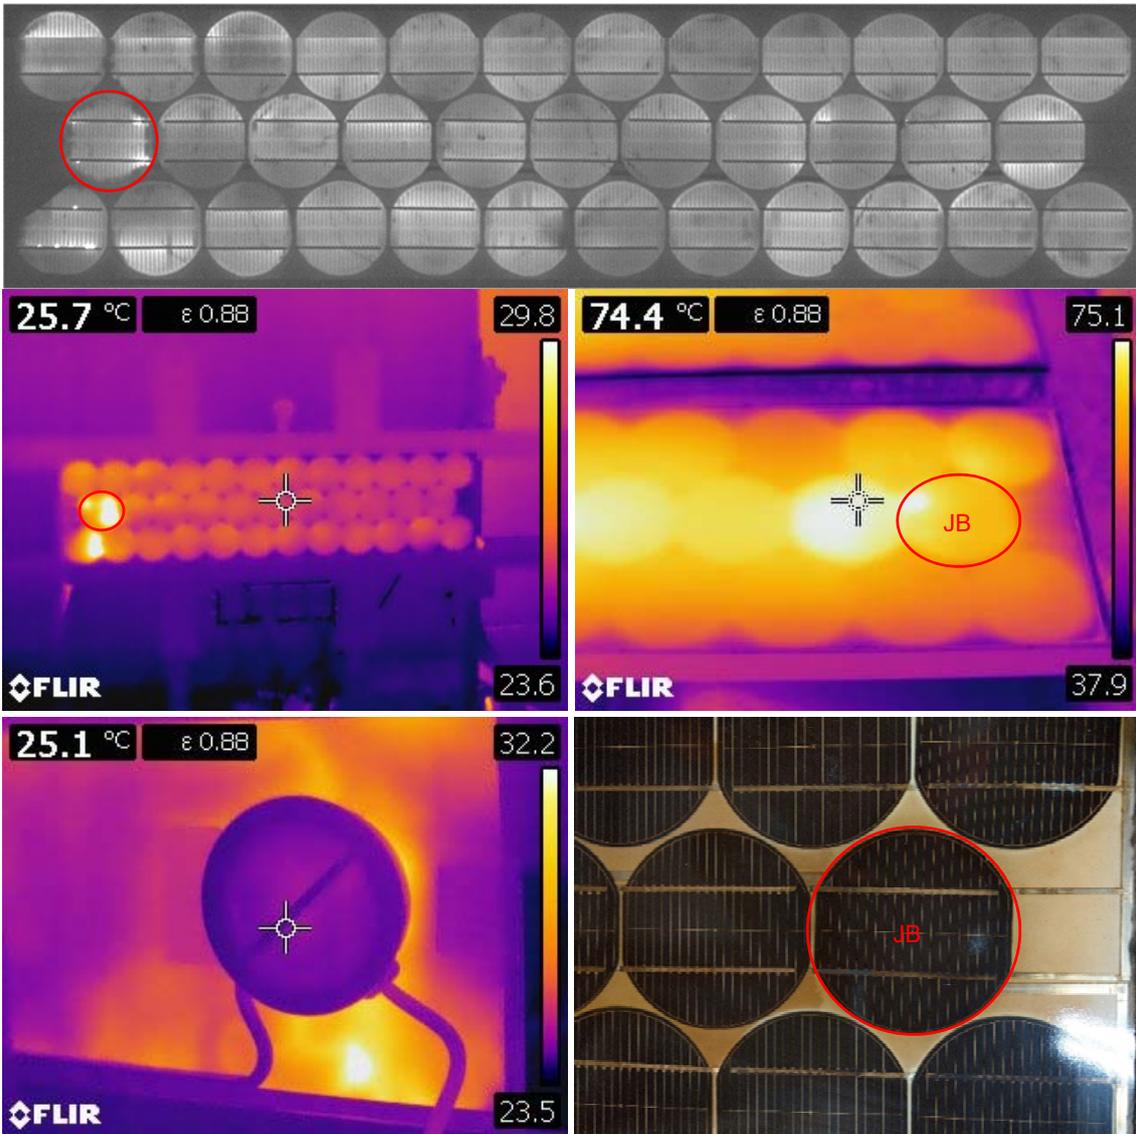
Figure 11: Comparison of Indoor (up, left) and outdoor IR (up, right): heating of the cell in front of the junction box is confirmed, different heat distribution is also clear. Below: indoor IR picture of JB (left) and Visual Inspection (right).

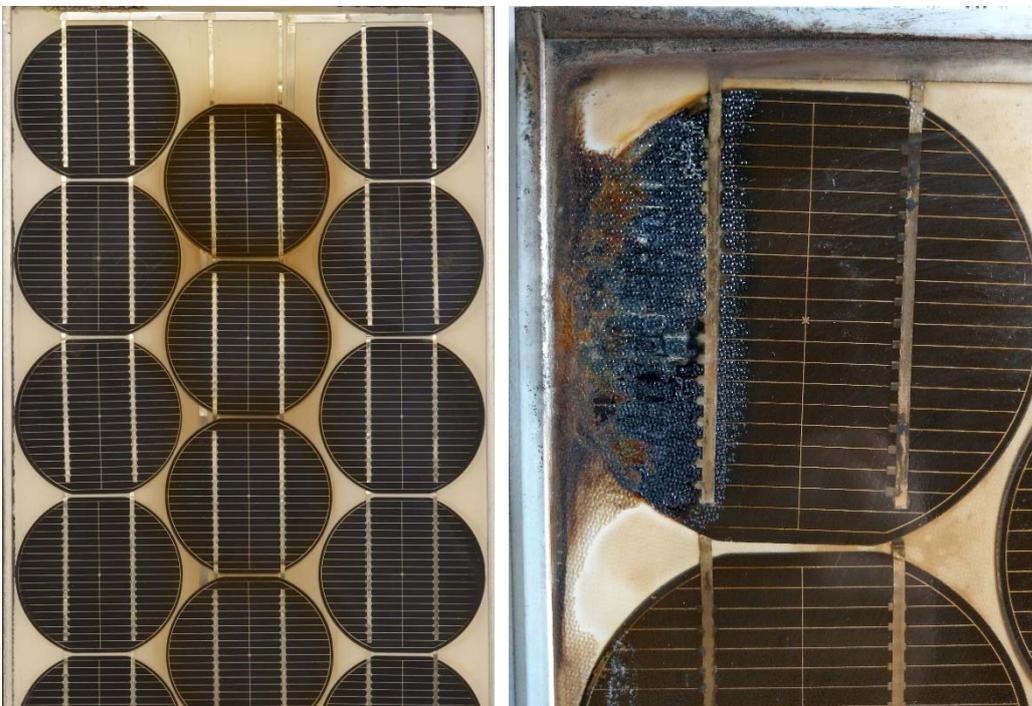
Figure 13: Soft defect (Left): yellowing of the central cells row; hard defect (right): delamination and corrosion of solar cell.

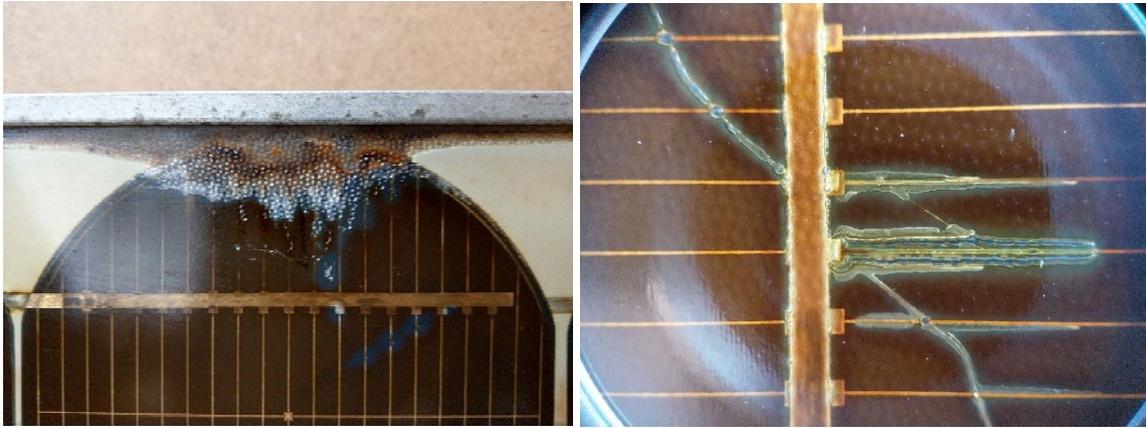
A vast majority of the modules are concerned by some type of front delamination (87.5% of the modules). Front delamination can consist in the separation between the glass and the front encapsulant, or between the front encapsulant and the cell. Front delamination can pose a safety risk when it forms a continuous path between the edge of the module and the electrical circuit, allowing for water ingress. An example is shown in Figure 18.

Figure 18: front delamination defect: left major, right minor.

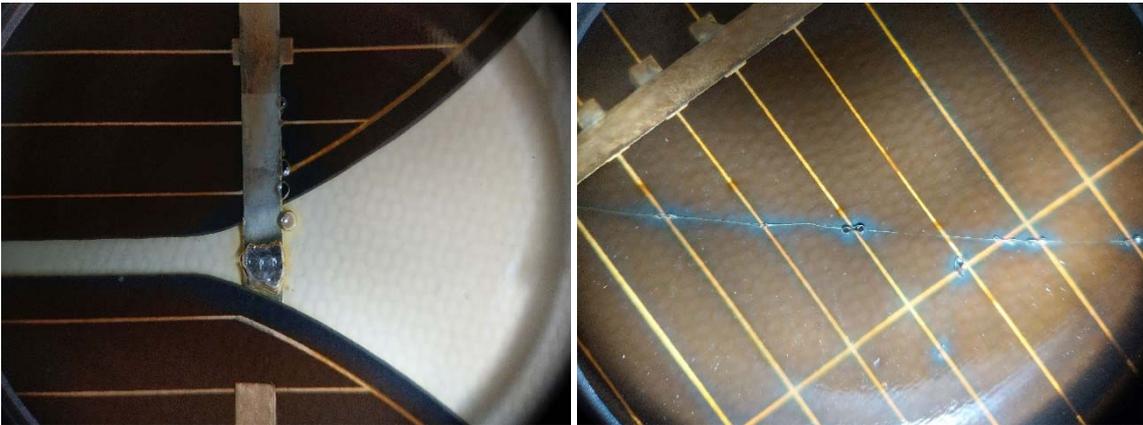
Figure 19: front delamination minor defect: bubbles.

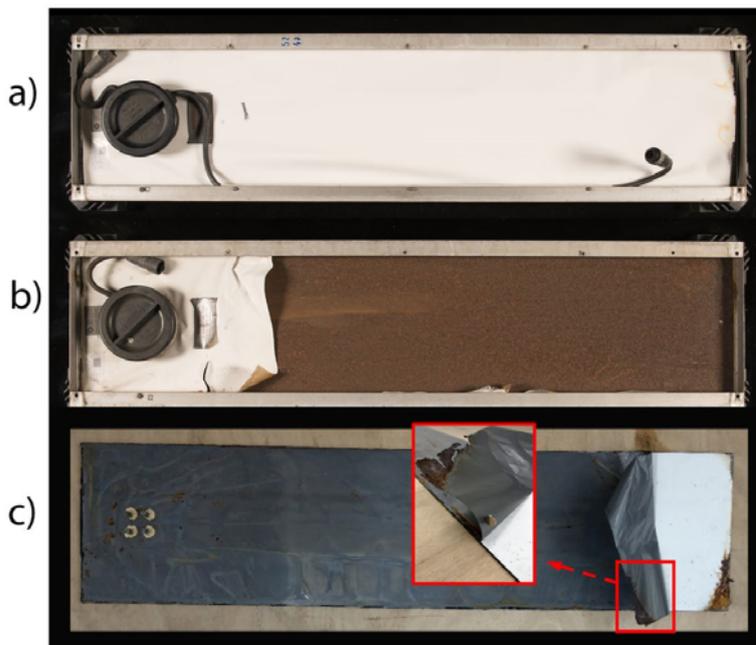
The backsheet material employed in these Arco Solar modules is made by three layers: Tedlar®/metal/Tedlar®. The metal plate is steel, as specified in the original datasheet and further verified during our inspection by means of a magnet. The presence of a metal plate makes the backsheet impermeable to water ingress, in contrast with the majority of the modules deployed in PV installations, which use a polymer foil backsheet. The backsheet in the Arco Solar modules presented a degradation mode that is peculiar to its design: a delamination of the external Tedlar layer from the metal plate. For most modules, indeed, the external Tedlar layer either (1) presents bubbles and wrinkles (66% of the modules) or (2) is to a large extent detached from the metal plate (32%). This can be seen in Figure 20 a) and b), respectively. When visible, the steel plate generally appears rusted, but without any major signs of rupture or cracks, which would severely compromise the sealing and the insulation of the electrical circuit. After performing a destructive analysis on one of the 288 modules, however, we noticed that the metal plate was cracked – even if still covered by the external Tedlar layer – and highly corroded in proximity of a corner. Burn marks were present as well, possibly the effect of arching due to the ingress of water from the module's corner (see Figure 20 c)). A cracked metal layer seriously compromises the insulation of the module, which would not pass a wet, and possibly a dry, insulation test. In the remainder of this paper, we will treat cases in Figure 20 a) and b) as a minor BS damage (i.e. partial or complete delamination of the external Tedlar layer from the – intact – steel plate). A major BS damage is flagged, instead, for this specific BS design, when the steel plate itself is cracked or damaged (Figure 20 c)). As the full detection of cracks in the metal layer would require a destructive analysis by separating the external polymer layer in all modules, we chose not to have any statistics on this failure mode. From the results of the insulation test (see Table 6), however, we speculate that this major damage affects only a minimal part of the modules and that, in general, the backsheets after 35 years are still working properly, providing electrical insulation and preventing moisture ingress into the encapsulant.

Figure 20: Damages to the modules' backsheet: a) bubbles & wrinkles in the external Tedlar layer leading to a partial delamination of this layer from the steel plate (not visible); b) Nearly complete delamination of the external Tedlar layer from the steel plate; c) corrosion and breakage of the internal steel plate, probably due to delamination and moisture ingress at the module's corner. Cases a) and b) are classified here as a minor backsheet damage, while case c) is a major backsheet damage (major safety risk).

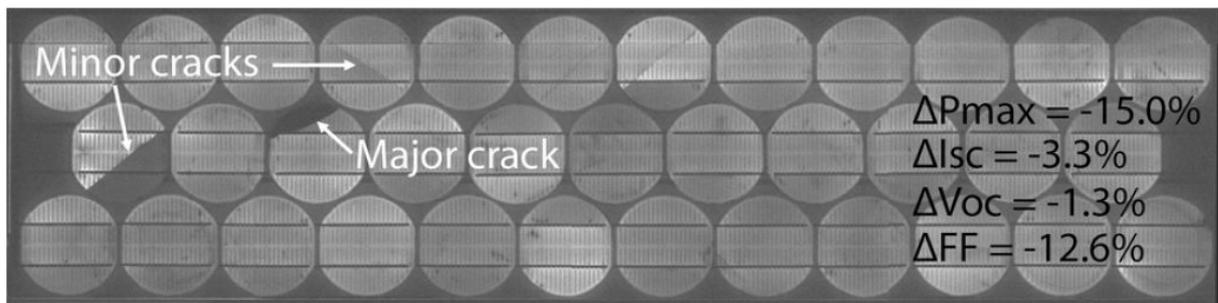
The Arco Solar modules of the TISO plant consist of 35 mono-crystalline Si cells. Cells are round with a diameter of 102.5 mm and a thickness of 330 μm . Over the years, the PV market has been constantly decreasing the thickness of cells to save on manufacturing costs, with the drawback of making them more fragile and prone to fracture. The cells employed in the ARCO Solar modules are thus more resistant against cracks than today's mono-crystalline c-Si cells, whose thickness is typically in a range as low as 180 μm . Nonetheless, many modules in the TISO plant present cracks in the cells, some of them also visible by the naked eye. By performing EL imaging on all the 288 modules, we classified the cracks into two categories, partly following the definitions proposed in ref. [36]: we define as a minor crack any crack that appears as a dark line or results in cell regions with a reduced EL intensity; a major crack represents instead a region completely separated from the electrical circuit (appearing as completely dark). Examples are shown in Figure 21. With respect to the nomenclature used in [36], minor cracks include "Mode A" and "Mode B" cracks, while major cracks correspond to "Mode C" cracks. As can be seen in Figure 22, minor cracks do not have a clear impact on the power reduction after 35 years compared to modules without cracks. Major cracks seem, instead, to be correlated with an additional -5.4% power variation. The large variance is due to the fact that (i) the current (and power) loss strongly depends on the portion of the cell affected by the defect [33], and (ii) other degradation modes might be present. We point out that some modules present cracks that span over more than one cell, suggesting that they were probably induced during transport or installation. These cracks are generally of the minor type.

Figure 21: Examples of minor and major cell cracks as defined in this work. The values indicate the relative variation (2017 vs 1982) of the electrical parameters with respect to the initial values (average values of the reference modules).

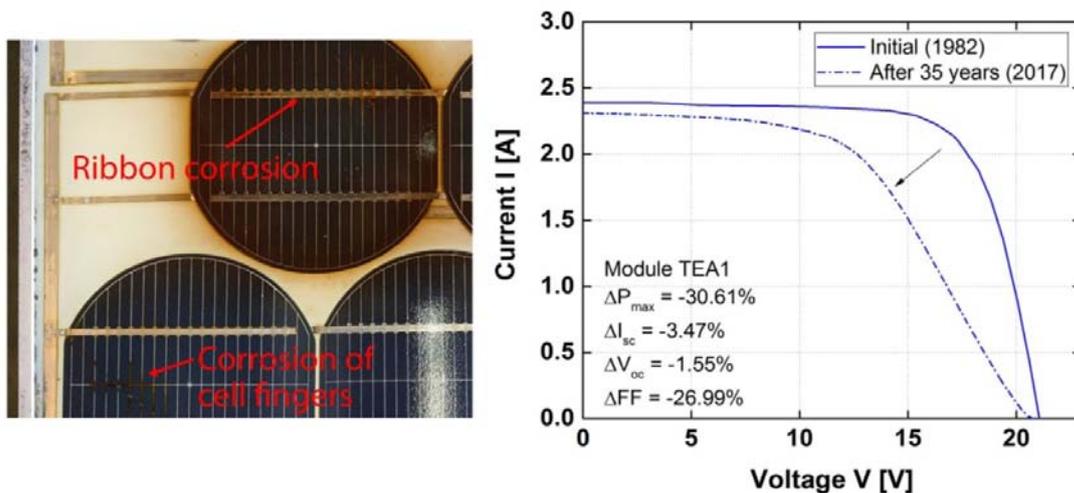
Module electrical interconnections, or internal circuitry (IC), are constituted by three levels of metallization. Following the nomenclature given in [37] and starting from the silicon surface we find: (1) the cell fingers and busbars, which are metallization lines directly printed over the silicon; (2) the ribbons, which are soldered over the cell's busbars and connect one cell to the other; (3) the string interconnects, which are metallic ribbons at the extremity of a line of cells, along the short sides of the module, not directly soldered on the cell but on the ribbons only. All these different interconnections can be subjected to degradation. In case of a strong oxidation, corrosion appears in the interconnections. Figure 23 a) shows a module with corroded interconnections on the cells above and close to the junction box. While in many cases the correlation between the IV curve and a given degradation mode is not straightforward, in this module we could identify a clear effect of interconnection corrosion on the 2017 IV curve (see Figure 23 b), characterized by an increased series resistance. The modules affected by IC corrosion are also affected by encapsulant yellowing.

Figure 23: Left: IC corrosion on a reference module (module TEA1). This module belongs to Class B (mild and localized encapsulant yellowing). Right: IV curves of the module TEA1 as measured initially (1982) and after 35 years. The strong increase in series resistance is most likely due to the corrosion in the interconnections. This effect results in a loss in FF of -27% .

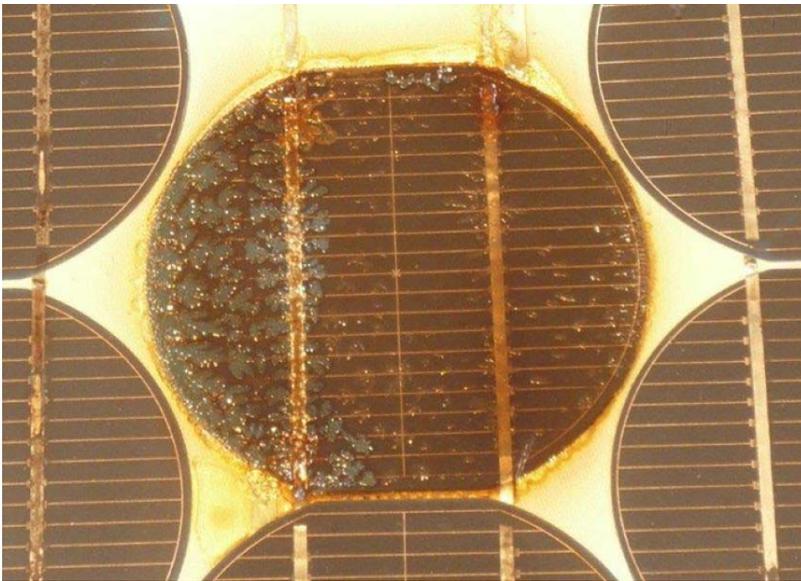
We define a hot spot as a cell (or an area of a cell) that is operating at temperature higher than the one of the surrounding cells. Some causes of hot spots are the presence of a cell that is forced to operate in reverse bias, for example because of a major crack, or the presence of resistive interconnections. Often, cells suffering from hot spots are those located over the junction box (see Figure 24), due in general to the worse thermal balance introduced by the box itself, and, in particular, for the unreliable electrical connection of the diode, without stress relief, often causing heating. Hot spots, in combination with a defective by-pass diode, may in the long-term seriously damage the surrounding materials and lead to burn marks (see next section).

Figure 24: In this module, the cell located over the JB shows a particularly severe case of hot spot (the cell is hotter than the other cells), which also lead to burn marks diffused all over the encapsulant and on the interconnect ribbons. IC corrosion is present as well, also visible in the interconnect ribbons on the left-side cells.

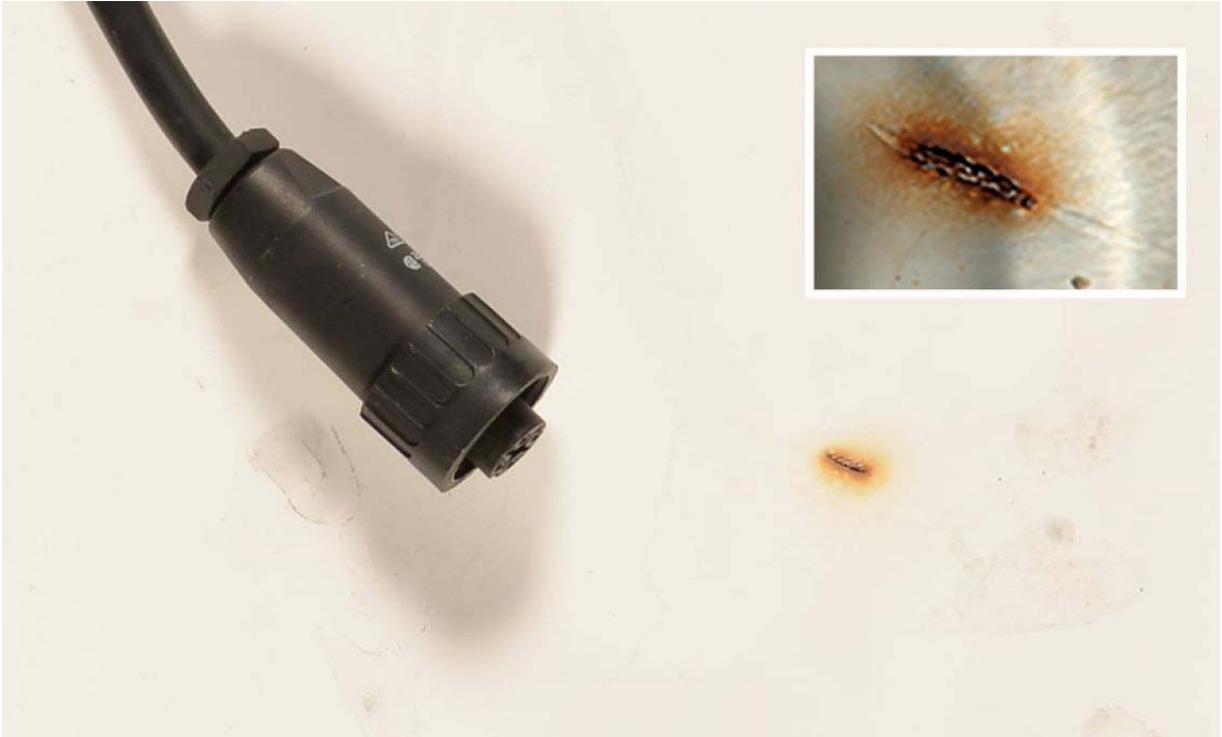
Burn marks are the effect of burns over the cells, interconnects, encapsulant, or backsheet and are caused by excessive heat. Burn marks were identified by visual inspection. Some of them are located on the interconnect ribbons, in correspondence to heating due increased series resistance (ribbon corrosion or partial ribbon detachment from the cell busbar, i.e. solder bond failure). Others appear on the encapsulant, often in proximity of cells with localized heating (hot spot), as was shown in Figure 10. Burn marks can also appear on the backsheet (not frequently observed here), where they may cause loss of insulation, see Figure 25.

Figure 25: Burn marks in the backsheet constitute a safety risk as they may cause loss of electrical insulation. The inset is a zoom on the defective area.

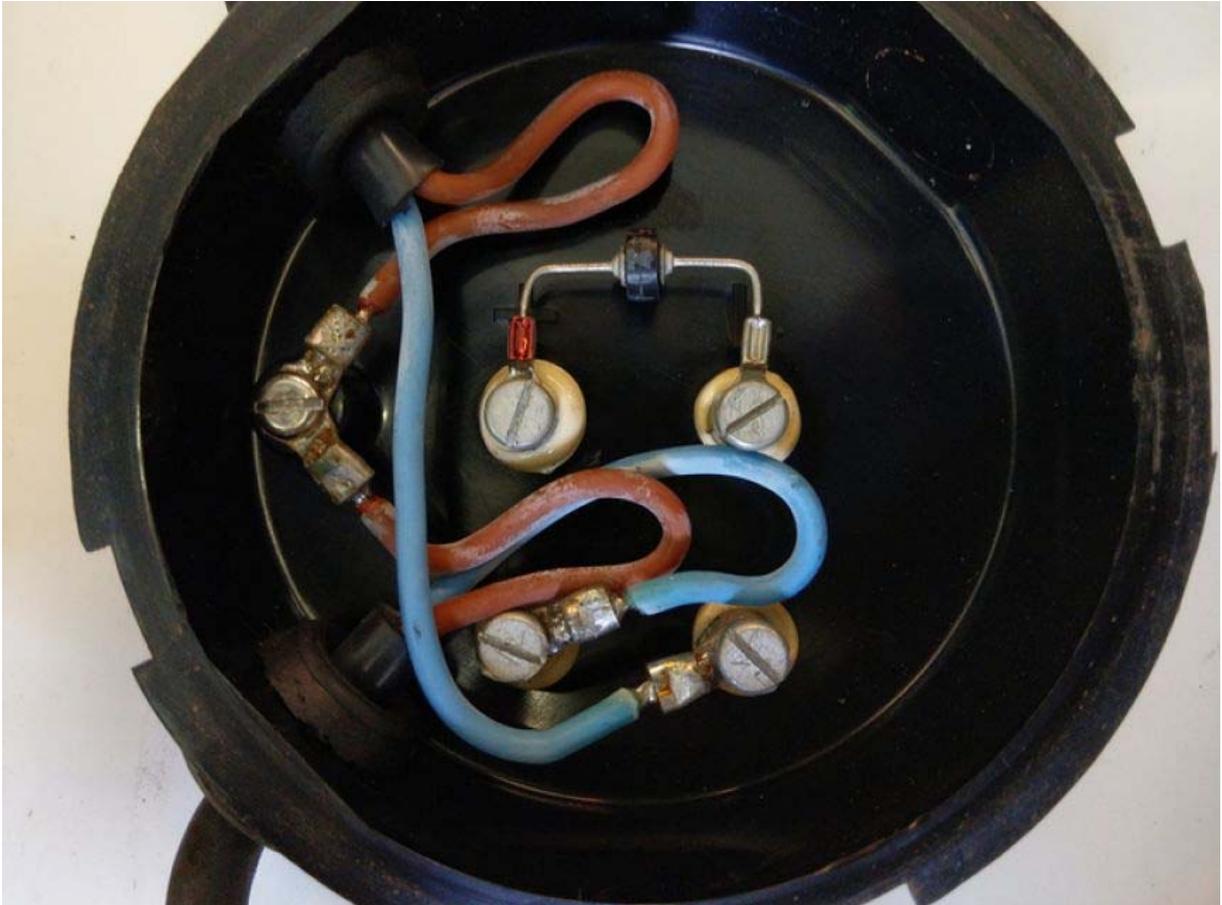
The junction box, hosting the module terminals and the by-pass diode, is closed on all sides (see Figure 26). In contrast with the designs commonly in use today, glued to the backsheet only along the four edges, in this case the contact surface with the backsheet is the full internal area of the junction box. Such weatherproof design allows the junction box to protect the electrical components from moisture, snow, or salt fog. In 9 modules (3.1% of the total) the junction box was found to be partially detached from the backsheet. By opening and inspecting some junction boxes, we found only in few cases oxidation of the metallic terminals and components (not shown here).

Figure 26: The inside of a junction box (the cover was removed for the inspection): the junction box is completely closed, also at the side in contact with the backsheet, which makes it particularly impermeable.

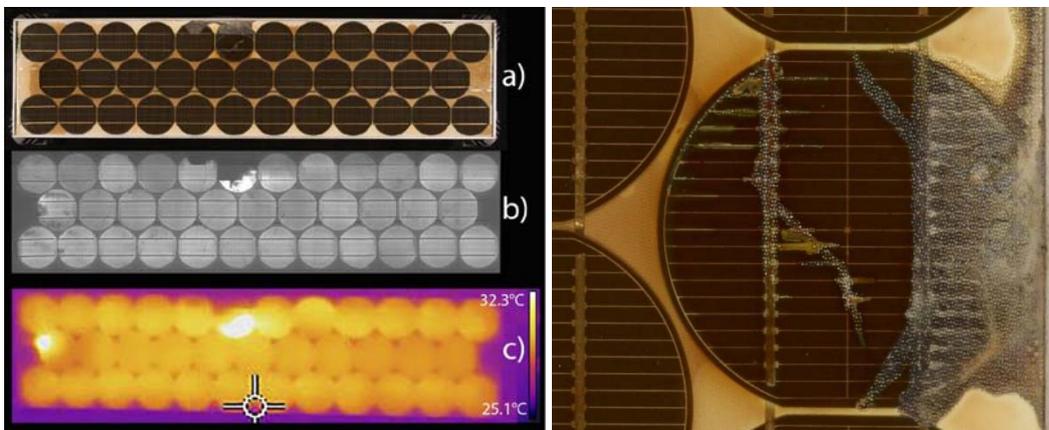
Figure 27: A severely degraded reference module (TEA9) affected by multiple degradation modes: a browning of the encapsulant affecting the three strings, front delamination, cell cracks, discoloration and corrosion of the interconnection ribbons.

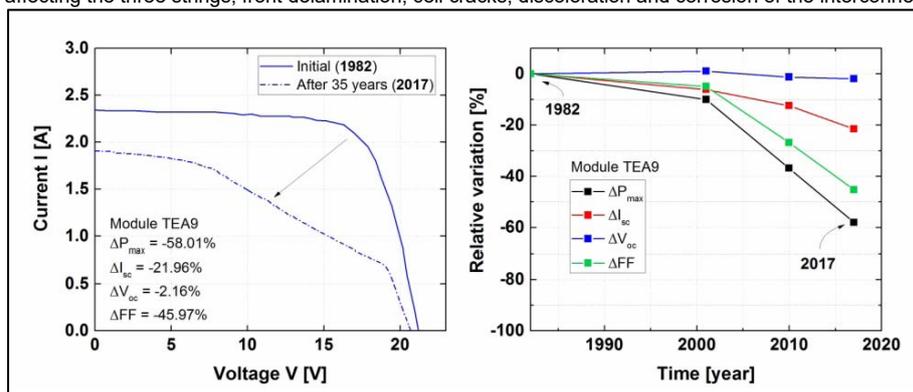
As we can see in Figure 28 on the right, the power degradation over the years is driven by FF degradation, and it follows a polynomial rather than a linear curve for a series resistance impacted module. We should however highlight that in 2001 (after almost 20 years of exposure) this module was still performing at 90% of its nominal power.

Figure 28: Comparison of the initial 1982 and 2017 IV curves for the reference module of Figure 27.
