# A European endeavor for optimizing Zonal Isolation, Drilling and Exploitation of EGS projects

## INSTALLATION OF THE WELLTEC PACKERS IN THE BEDRETTO UNDERGROUND LAB FOR GEOSCIENCES AND GEOENERGIES (BULGG):

ACTIVITIES CARRIED OUT IN THE FRAMEWORK OF THE  
GEOthermica/ZoDrEx RESEARCH PROJECT

Authors: F. Christe, P. Meier

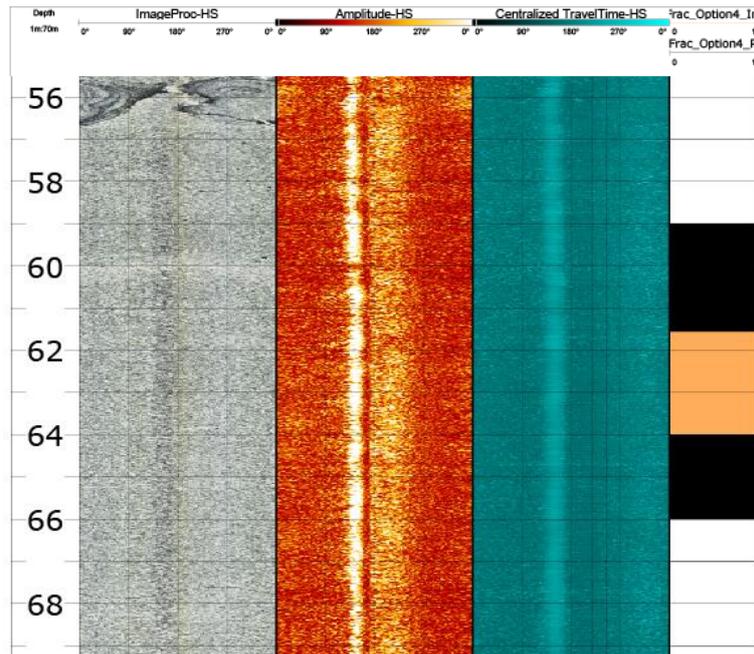
Figure 1. Interval 1: Detail of the packer placement with the Acoustic/Optical televiewer logs

The borehole is cut at 101 m by a fracture, which has a distinctive signature and which can be traced all the way through the other boreholes to the tunnel. Based on the ATV and OTV logs, two sections (Figure 1 and Figure 2) with little signs of pre-existing fractures were selected for the planned stimulation tests.

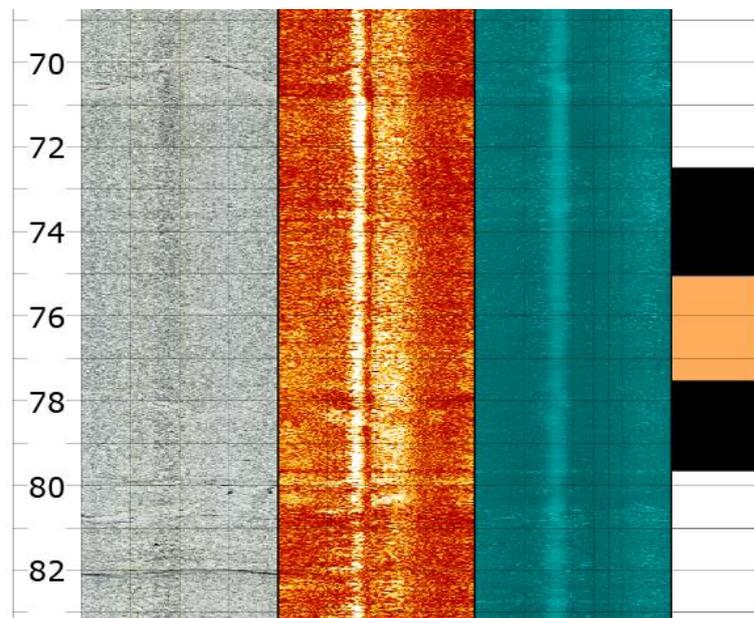
Figure 2. Interval 2: Detail of the packer placement with the Acoustic/Optical televiewer logs

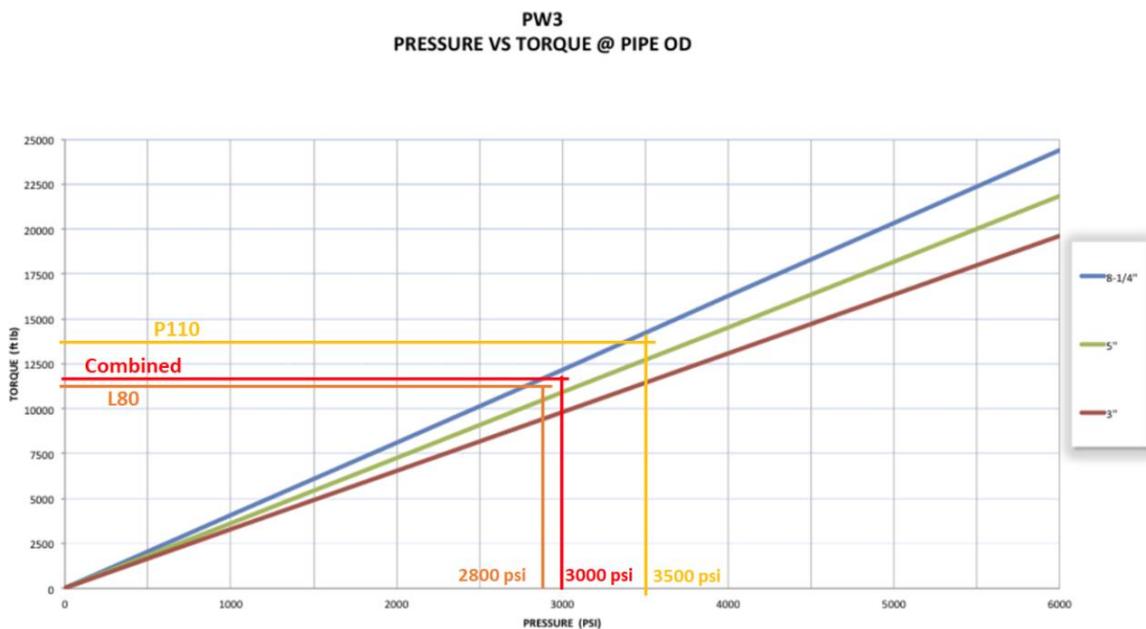
Figure 3. Calculated torque vs pressure for different pipe outer diameters (OD) for an AUTOTORQ hydraulic chain pipe wrench of model PW3 as provided in its manual. A virtual line with an OD of 7" was drawn, indicating the torque needed for a joint-joint (L80), joint-packer (Combined) and packer-packer (P110) connection and the necessary pressure to be reached with the hydraulic aggregate.

The tightness of the joint-joint, joint-packer and packer-packer connections was reached through the torquing of the connections with an AUTOTORQ hydraulic chain pipe wrench of model PW3 and a hydraulic aggregate of type HYFLOW 230V-2 (Figure 11). The necessary torque values were calculated by the Welltec engineers and the corresponding pressures to be reached with the hydraulic aggregate can be read on Figure 3. The pressures on the joint-joint (L80), joint-packer (Combined) and packer-packer (P110) connections were 2800 psi, 3000 psi and 3500 psi respectively.

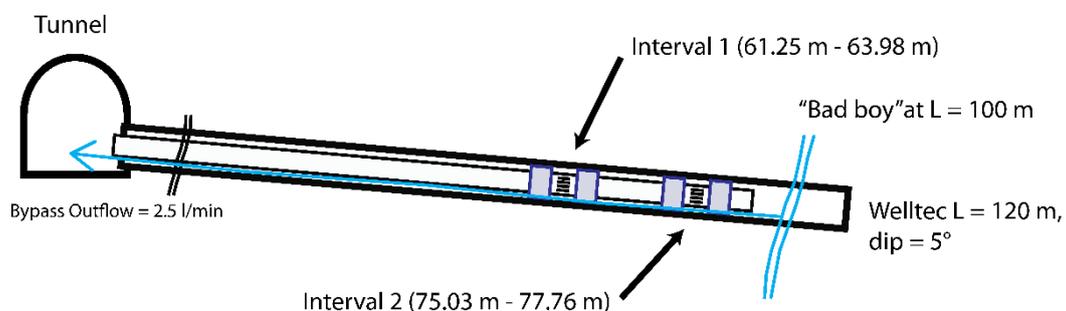
Figure 4. Schematic view of the final configuration of the packers and the intervals top and bottom depths before the hydraulic tests.

the next two WAB, twenty joints of 3 m length and one last joint of 2 m length. In the final configuration, the stick-out of the last joint is 0.44 m from the flange. Therefore, the bottom of the casing is closed at a depth of 83.017m. The first interval is between 61.253 m and 63.985 m while the Welltec Flow Valve (WfV) is at 62.65 m. The second interval is between 75.027 m and 77.76 m while the WfV is at 76.43 m. Both intervals have a length of 2.733 m. The detailed Tally list of the final packer configuration can be found in Chapter 6 Annexes Welltec Tally list of the packer installation.

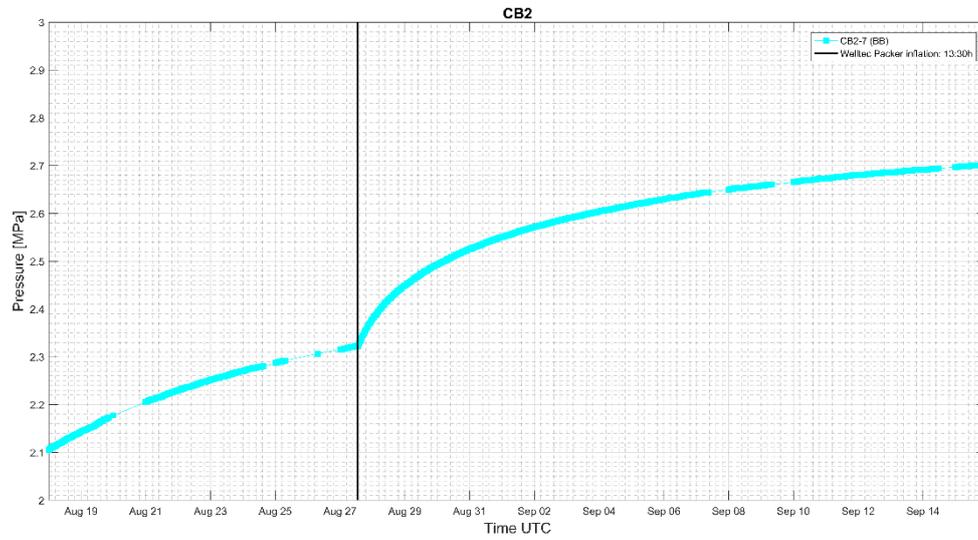
Figure 5. Pressure reaction at the interval CB2-7 during the Welltec packer expansion

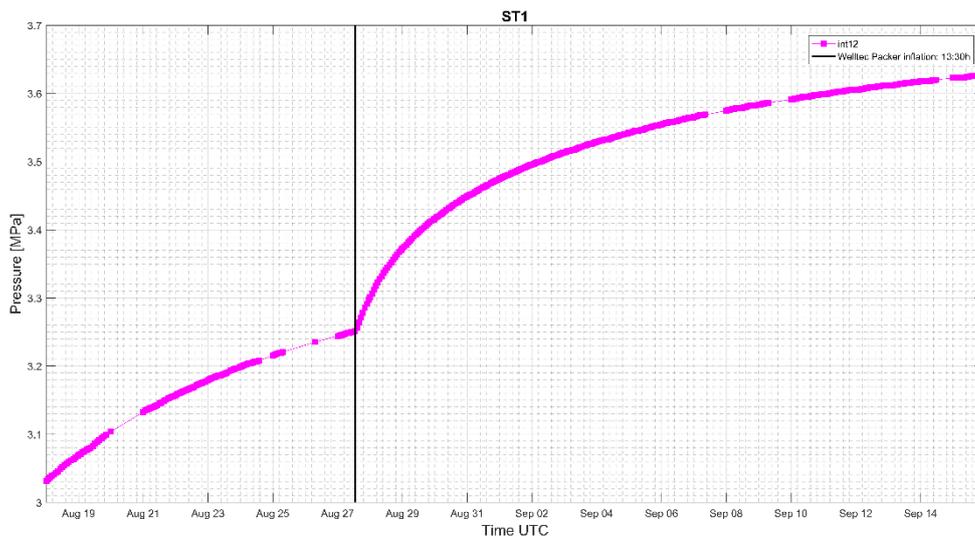
Figure 6. Pressure reaction in ST1 at the interval 12 during the Welltec packer expansion

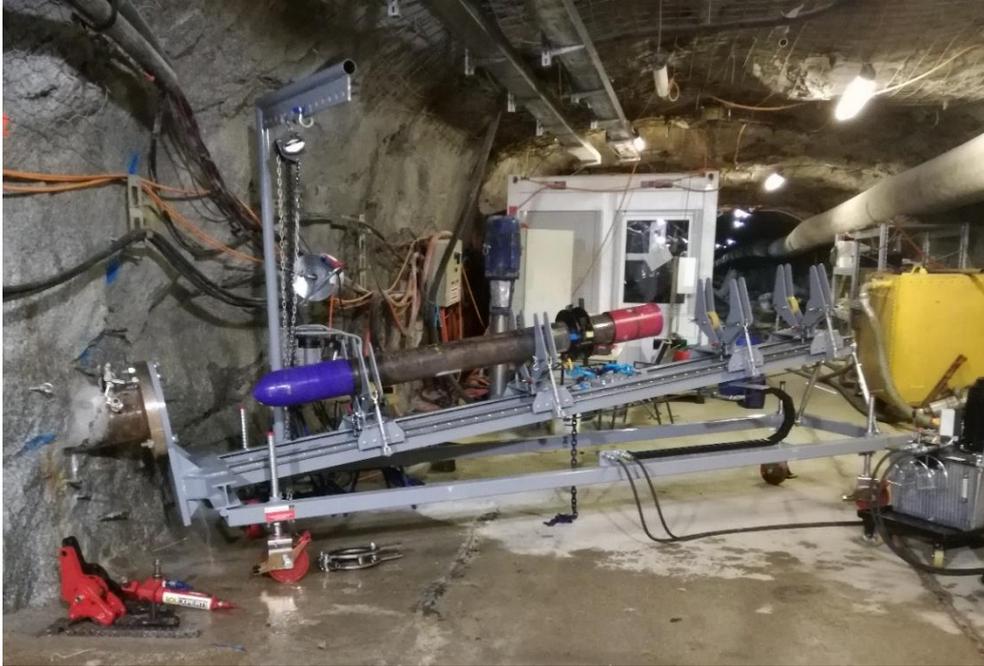
*Figure 7. the pushing rig and the floating shoe placed onto ready to be lowered into the borehole*

The packer installation operation started with the installation of a pushing rig in front of the Welltec borehole. The pushing rig was necessary to overcome the friction force due to the 5° inclination of the borehole. The floating shoe, which closes the bottom of the 7" casing (Figure 7), was installed on the pushing rig and lowered into the borehole. Then, two packers, marketed under the WAB (Welltec Annular Barrier) trade name with a length of 3 m and an outer diameter of 7", were screwed onto the floating shoe (Figure 8, Figure 9 and Figure 10), followed by three joints of 2 m. Following this, came

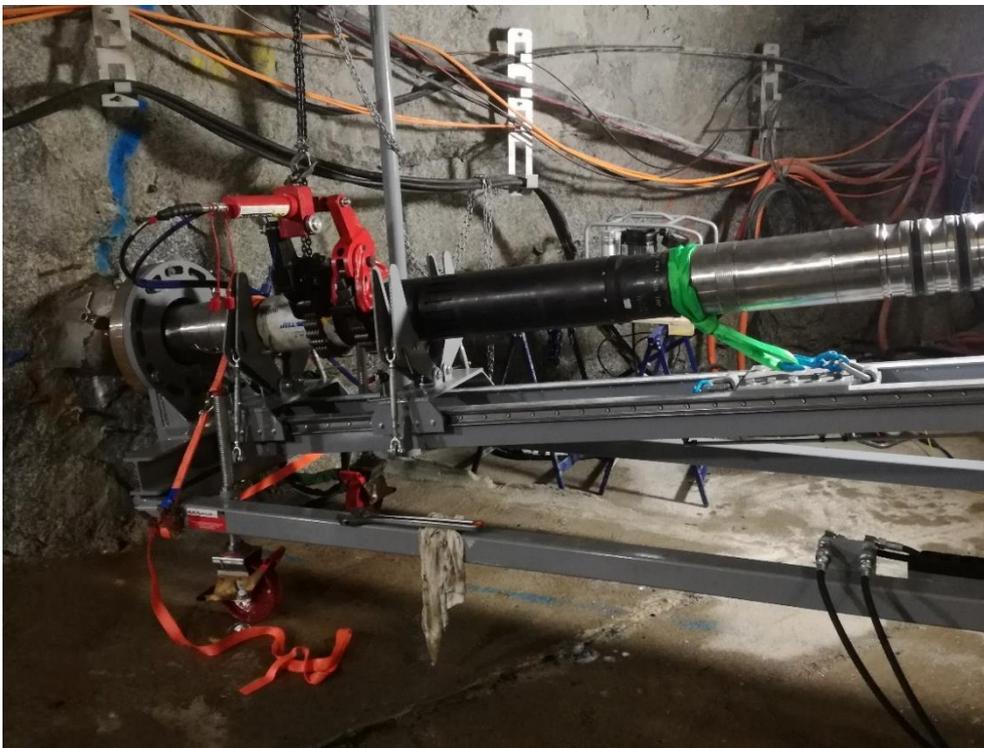
*Figure 8. the second WAB and the WFV being torqued onto the 1st packer*

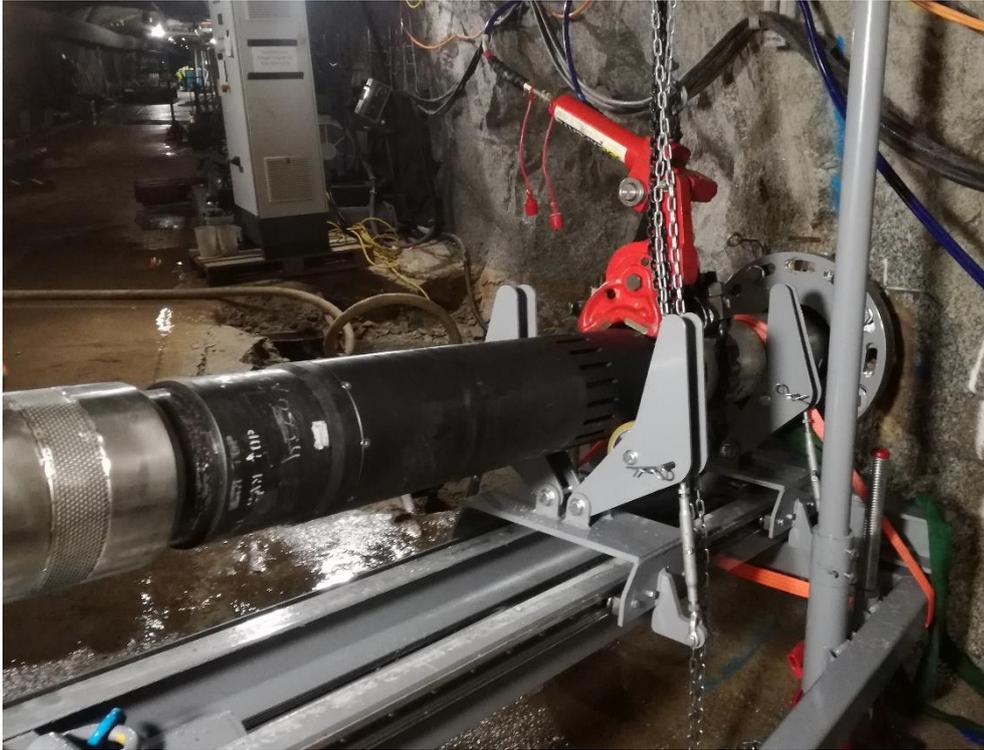
*Figure 9. Closer view of the second WAB and the WFV being torqued onto the 1st WAB*

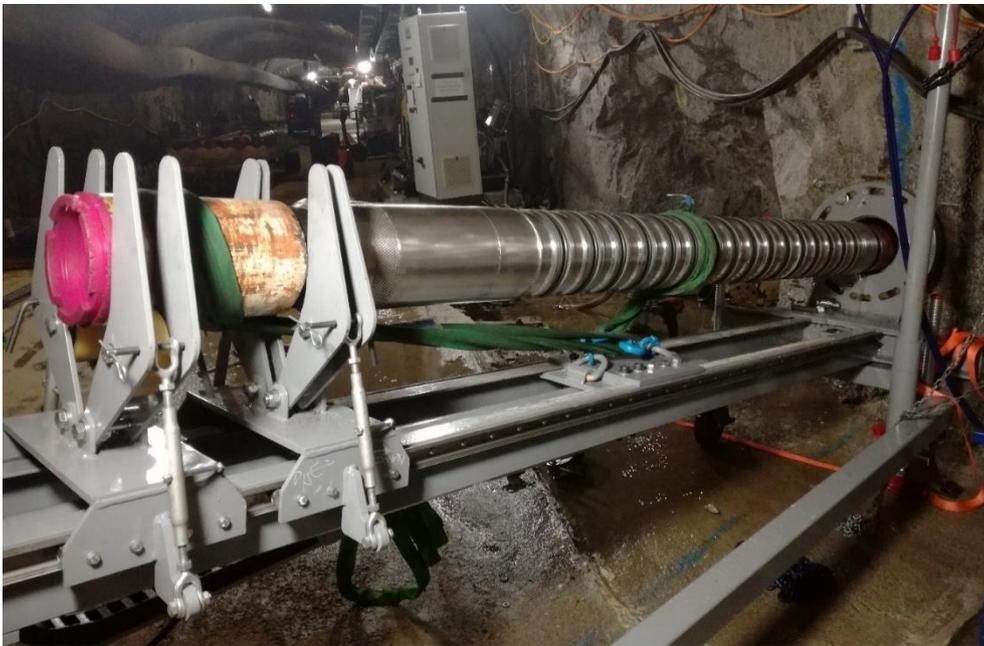
*Figure 10. The 2nd WAB being lowered into the borehole with the pushing rig*

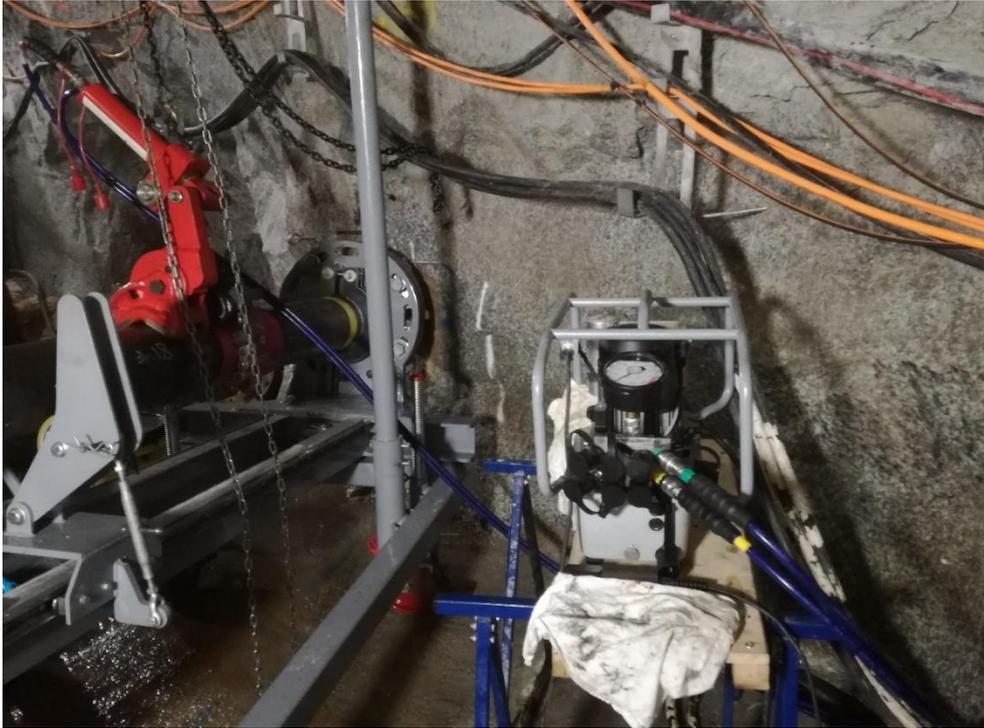
Figure 11. The hydraulic aggregate and the AUTOTORQ hydraulic chain pipe wrench

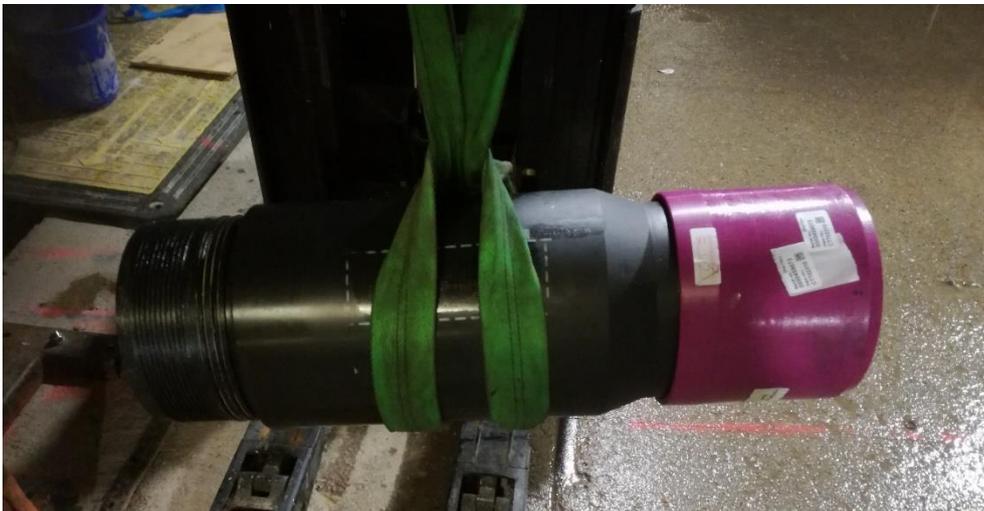
Figure 12. The junction piece before torquing it onto the last 2 m casing joint

For the packer expansion operation, a junction piece (Figure 12) was torqued onto the last casing joint and a wellhead piece (Figure 14) was screwed onto it. The tightness between the junction piece and the wellhead piece was insured by O-rings (Figure 13). Then, a pressure gauge, the necessary valves, a high-pressure hose and a pump were connected to the wellhead piece to fill the casing with water and to evacuate the air (Figure 15 and Figure 16). Following this, the packers were expanded by increasing the pressure inside of the casing and inside the packers with a pump of model P21/7-400 affording flowrates up to 6.8 l/min and pressures up to 40 MPa. As shown in Table 1, the expansion of the 4 packers was carried out in steps of 2 minutes, increasing at each step the pressure by 3.5 MPa (500 psi) up to a last step of 10 minutes at 34.8 MPa (5000 psi). The packer expansion operation started

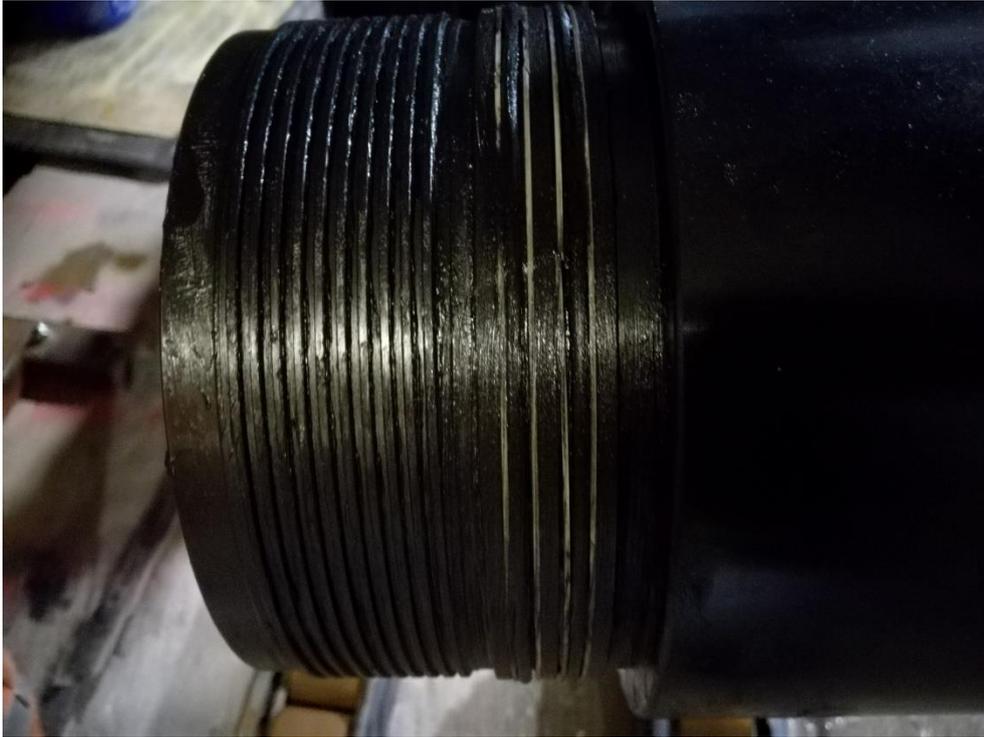
*Figure 13. Detail of the O-rings ensuring the tightness between the junction piece and the metallic wellhead piece for the injection*

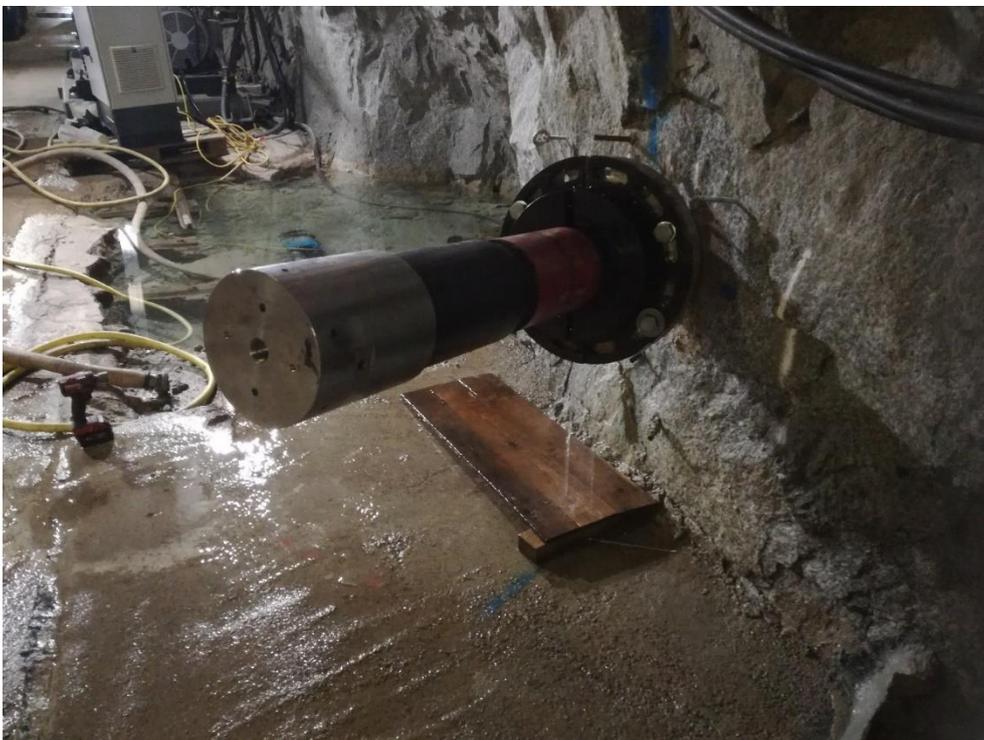
*Figure 14. The metallic wellhead piece screwed onto the junction piece shown in Figure 12*

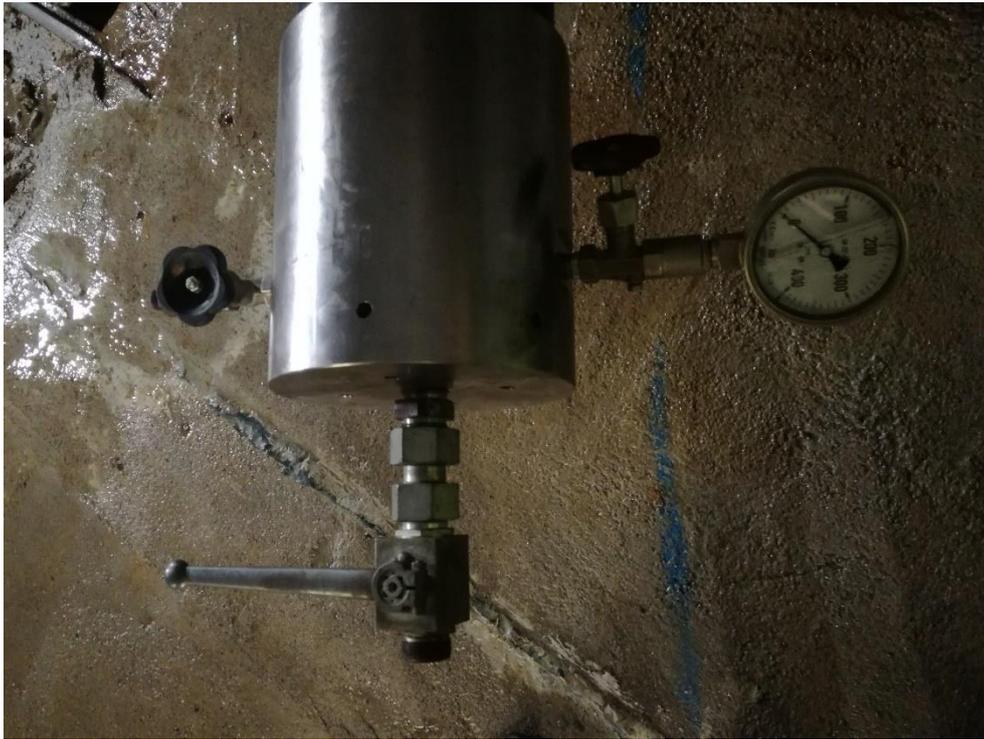
Figure 15. Detail of the pressure gauge and valves on the metallic wellhead piece for the packer expansion

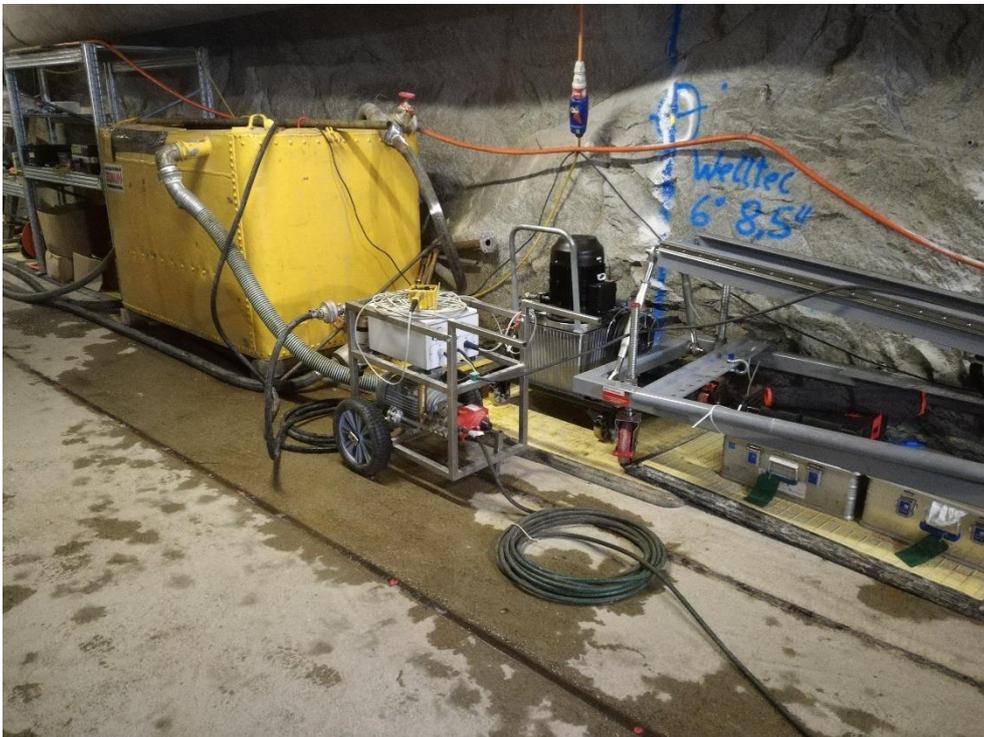
Figure 16. The pump used for the packer expansion

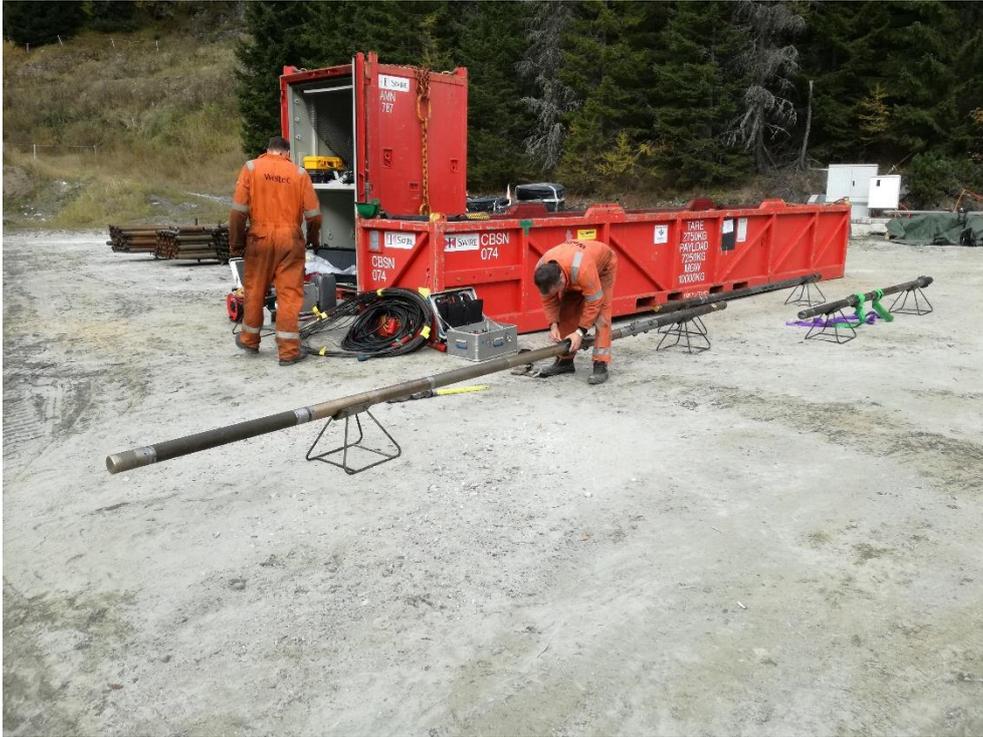
Figure 17. The Welltec tractor tool before assembly.

The goal of the stimulation phase of the Welltec work consisted in the hydraulic stimulation of the interval 1 and in a second step of interval 2. To operate in inclined boreholes, Welltec has developed and uses a tractor tool that can overcome the friction forces by driving down the boreholes with wheels. To open the sliding sleeves, the tractor tool has keys to latch on the sliding sleeve, anchors to immobilize the tractor and a piston to move the keys and thereby operate the sliding sleeve (Figure 17, Figure 18).

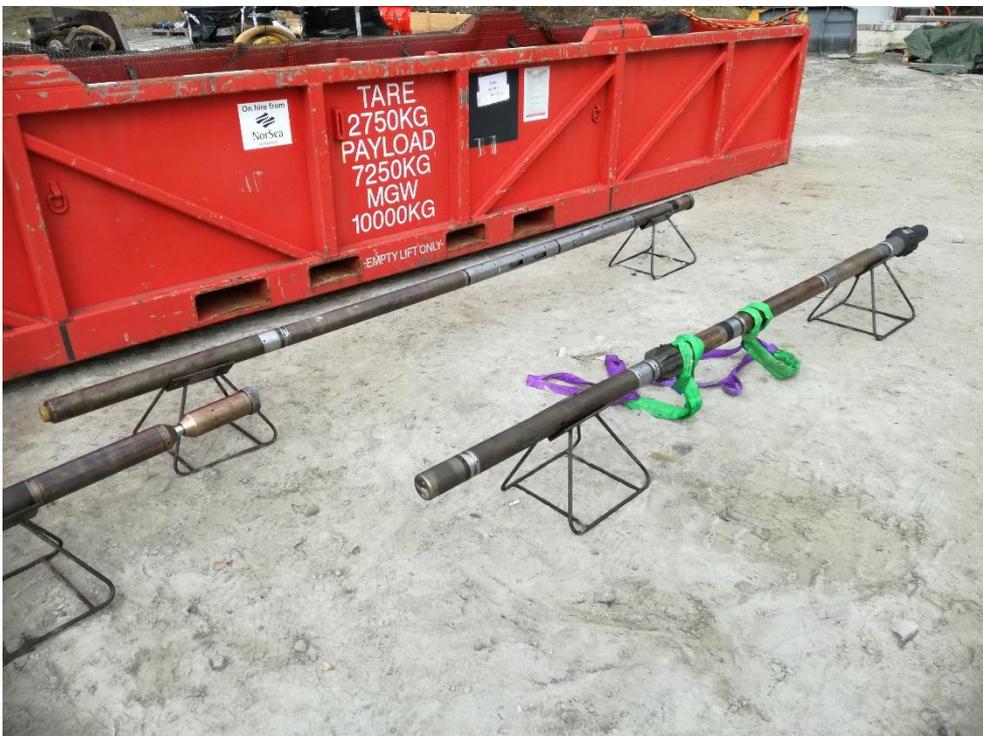
Figure 18. Parts of the tractor tool. On the first plane (on the right), the part with the keys that latch onto the sliding sleeve. On the second plane (on the left), the part with the piston and the ankers. The ankers are not visible on the picture. On the third plane (in the center), the part with the wheels.

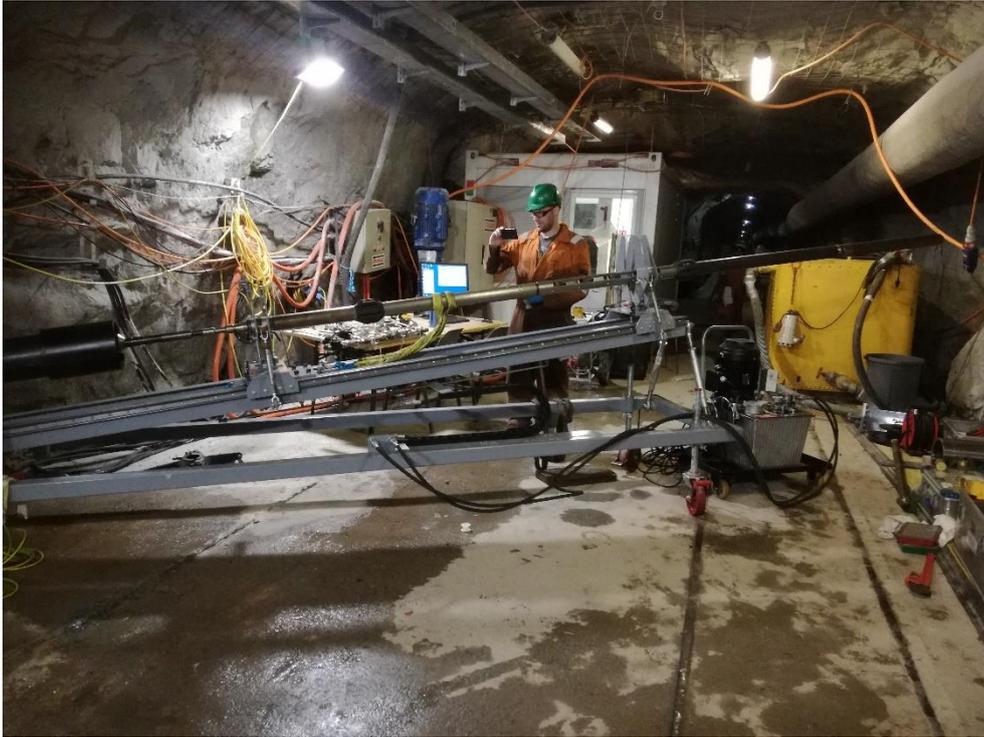
*Figure 19. The tractor tool for fishing operation ready to be lowered into the borehole.*

The shifting tool was successfully retrieved on 27.10.2021 with a new tractor tool that had to be delivered to the Bedretto site (Figure 19). The retrieved tool was tested in a spare sliding sleeve and in spare casing parts on the floor of the lab to control if there was some damage from the cable head snapping and its stay in the borehole (Figure 20, Figure 21, Figure 22 and Figure 23). A manoeuvre to open the sliding sleeve of interval 1 was performed on 28.10.2021, this time with a working equipment which could measure the pulling pressure on the cable head. No change in the flow coming out the

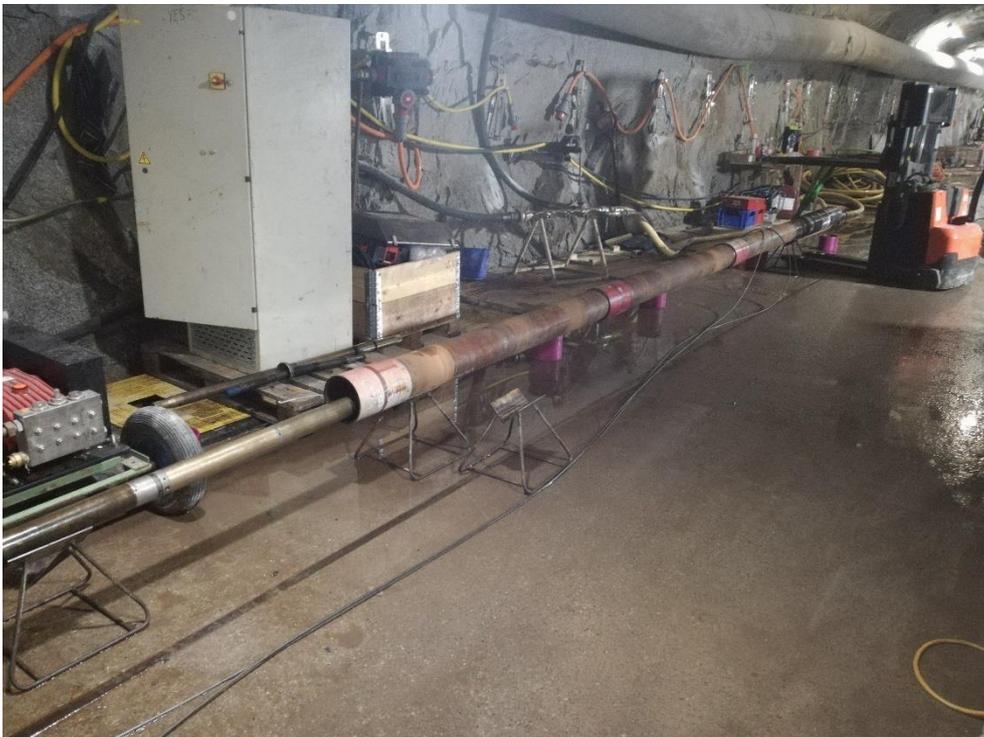
*Figure 20. The fished tractor tool being tested at the surface in spare casing parts and a spare sliding sleeve*

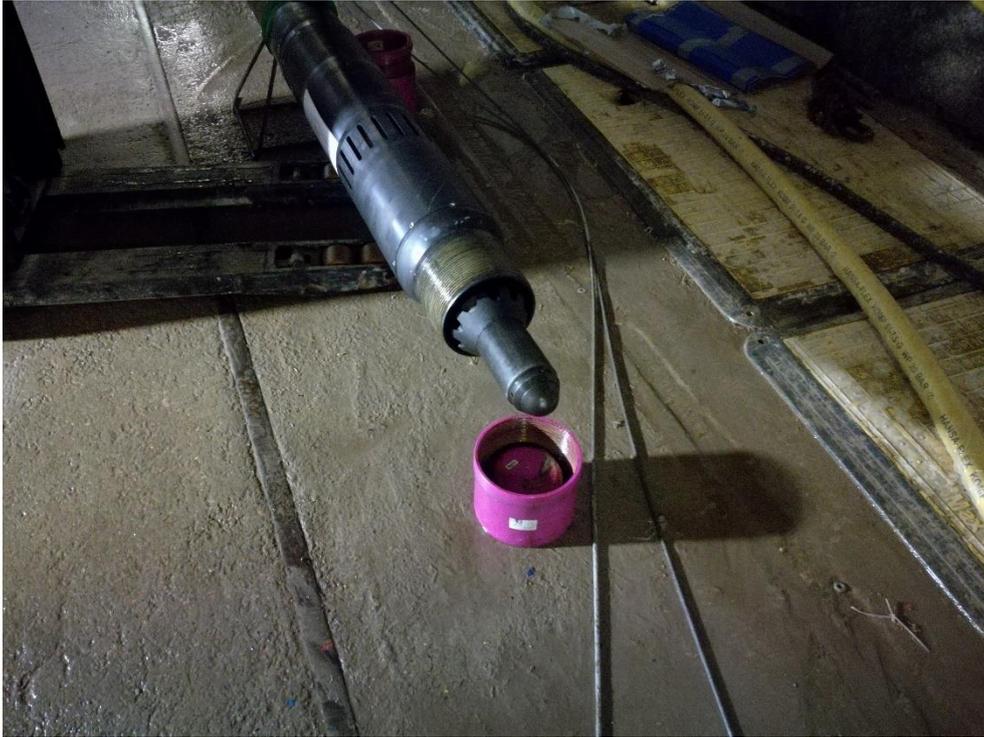
*Figure 21. The fished tractor tool being tested at the surface. To open the sliding sleeve, the keys are below the sliding sleeve before setting them out, setting out the ankers and pulling the sliding sleeve by closing the piston.*

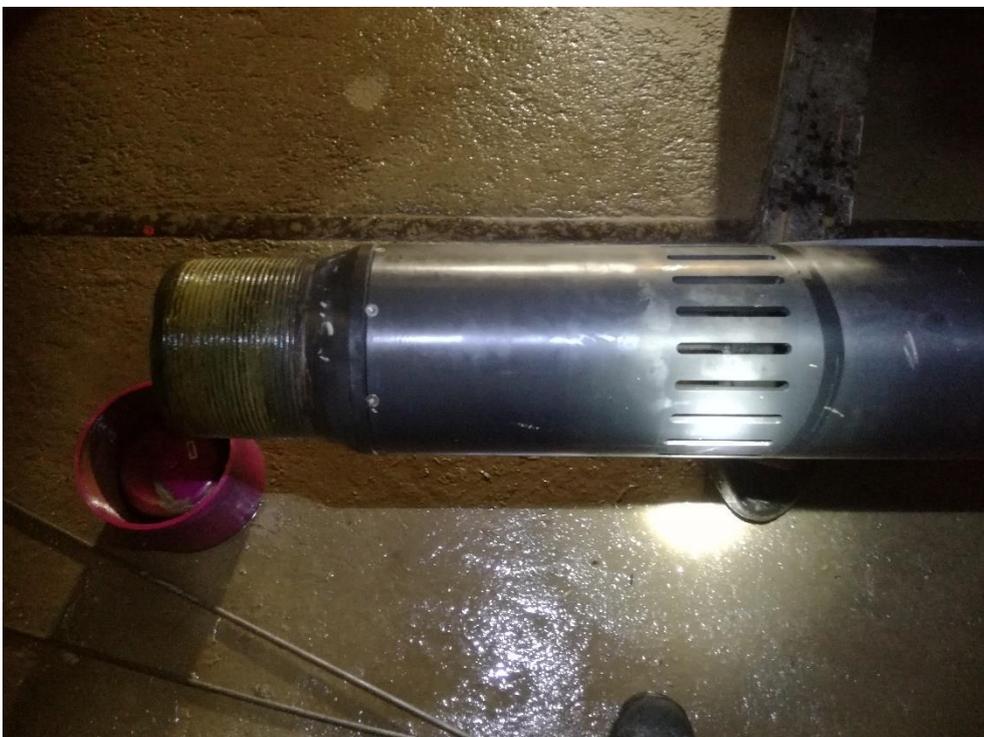
*Figure 22. The sliding sleeve is open after the testing of the fished tractor tool.*

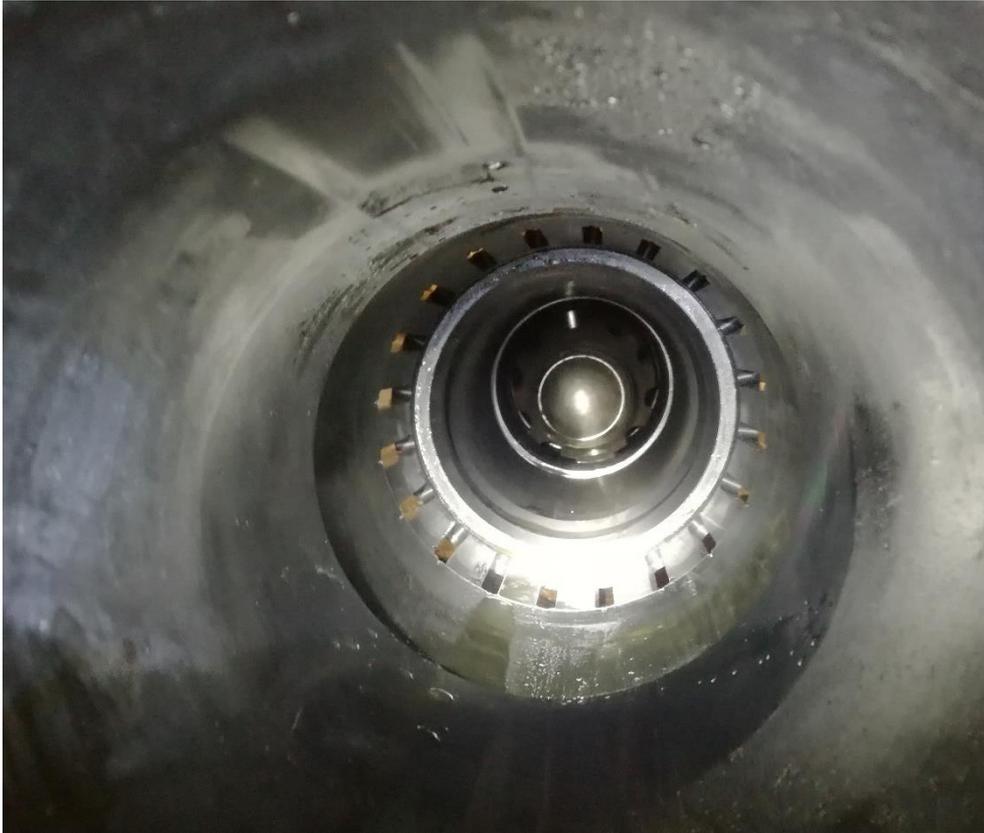
*Figure 23. The sliding sleeve in the open position seen from inside with the head of the tractor tool visible on the last plane.*
