Swiss Federal Office of Energy
Energy Research and Cleantech

Final report from 4 December 2025

PV-DETECT

Accelerated product development for
unconventional PV-applications through
advanced reliability testing combined with
early degradation detection

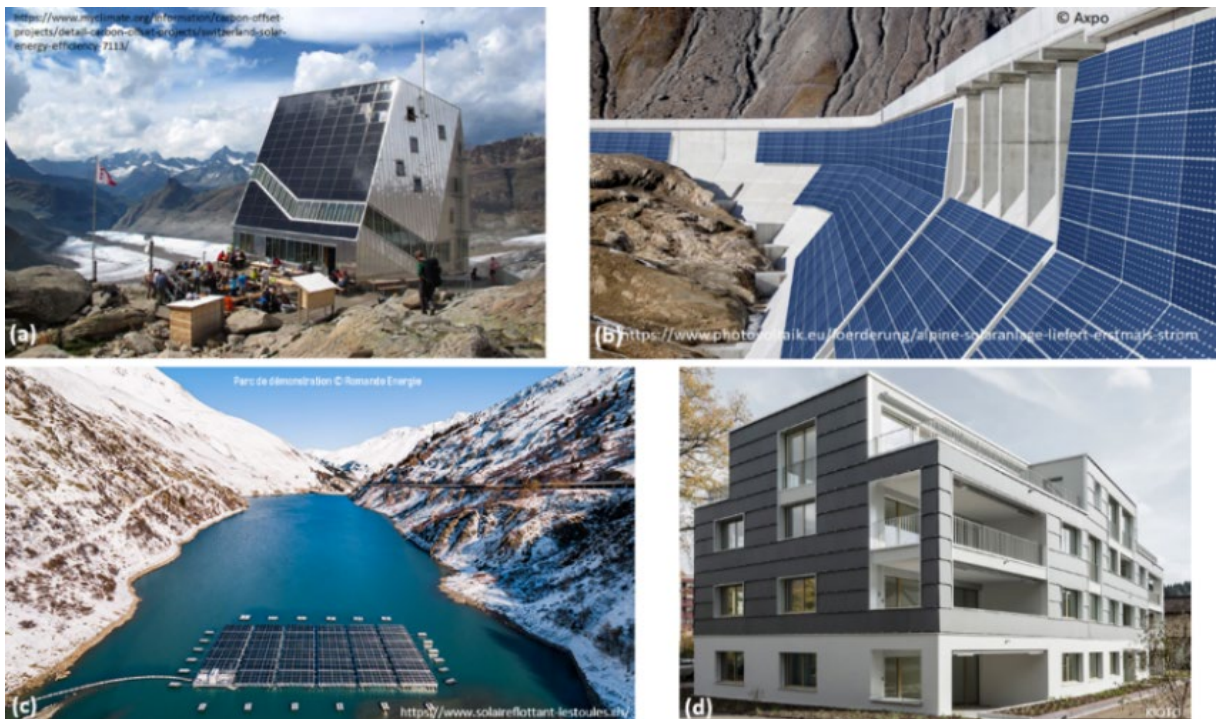
Figure 1: Examples of pilot projects for PV in an alpine environment: (a) "Monte Rosa SAC Hut", (b) 2.2 MW PV system dam Mutsee, (c) "Lac des Toules" in Switzerland and (d) BIPV (façade) system in Austria.

- (i) integrated solutions in the built environment (e.g. building roofs, façades, and infrastructure),
- (ii) dual-use applications that combine energy generation with existing structures (e.g. PV on infrastructure), and
- (iii) ground-mounted PV systems in mountainous areas, where larger installations are technically feasible but exposed to harsh environmental conditions (Figure 1).

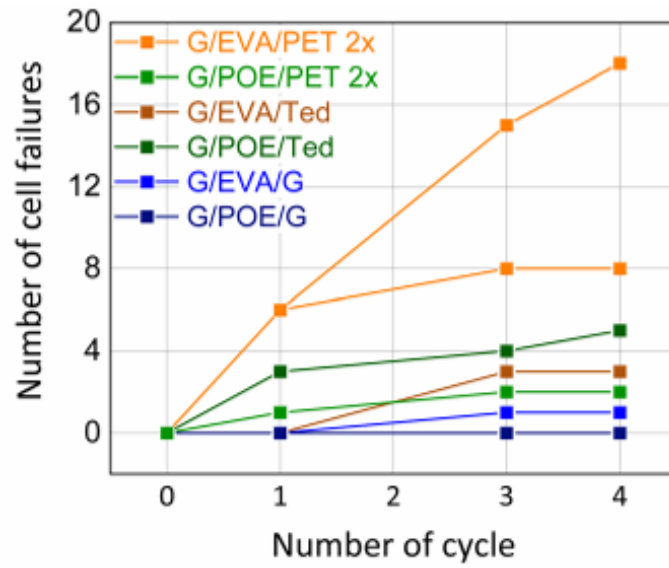
Figure 4: Number of failures (cell cracks, micro cracks and solder bond failures) in the eight mini modules after each cycle of the accelerated test sequence including dynamic mechanical loading [17].

After four cycles (49 days total), the material and electrical measurements indicated initial signs of degradation in the test mini-modules. In particular, the dynamic mechanical load steps induced cell cracking, despite the applied pressure being only approximately 2000 Pa (around 0.1 m² sample area) (Figure 4). EL imaging was performed after the first, third, and fourth cycles. By the end of the sequence, six of eight modules exhibited new microcracks or cell cracks of varying severity (Figure 5). These defects resulted in maximum power degradation between -3.3% and -8.2%.

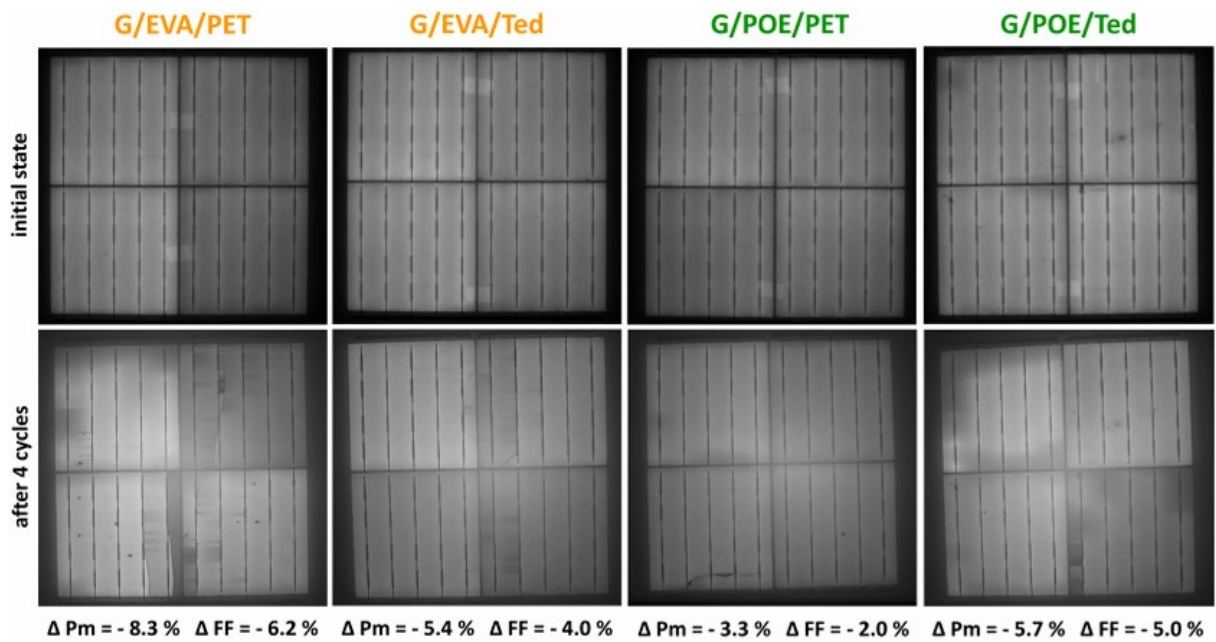
Figure 5: EL images of all 4-cell test mini-modules after four test cycles [17].

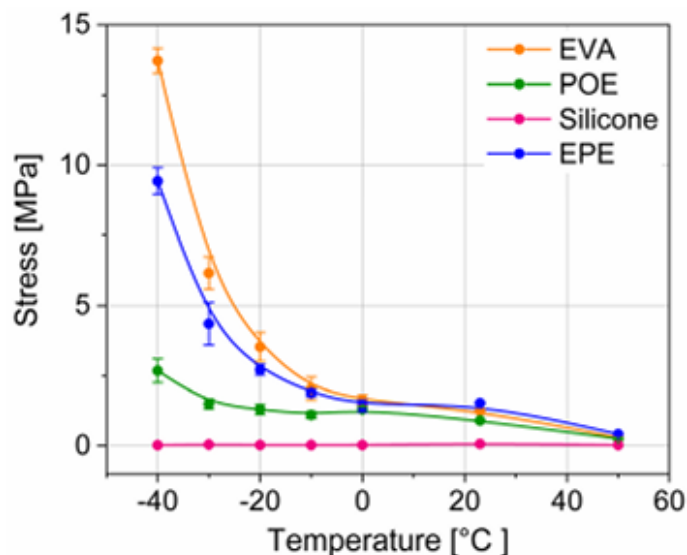
Figure 6: Tensile strength measurements of encapsulants. Lower tensile strength corresponds to a more elastic encapsulant [17].

Tensile strength tests were then carried out according to ISO 527-2 at various temperatures. The tensile strength at 100% elongation was compared across different encapsulants and temperatures (Figure 6). Encapsulants with lower glass transition temperatures, such as POE or silicone polymers, maintain their elasticity even at low temperatures, providing optimal protection for the cells against high mechanical loads, particularly in situations with high snow loads and wind during cold weather.

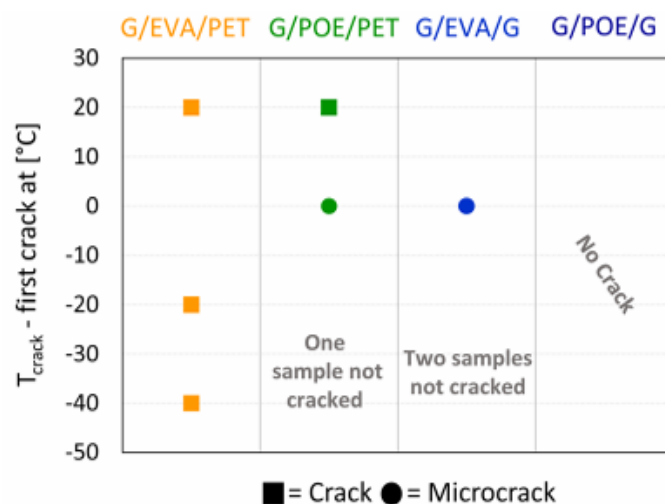
Figure 7: Appearance of first cell cracks during the static three-point mechanical load test on mini-modules at various temperatures.

Afterwards, static three-point mechanical tests were performed in a climate chamber at temperatures from +20°C to -50°C to evaluate low-temperature mechanical stability across module structures and encapsulants under a load of 5400 Pa. The temperature was decreased in steps of 10 °C, and at each step, a load was applied for one hour. EL imaging was performed between temperature steps to detect newly formed cell cracks and to correlate crack initiation with encapsulant behaviour and temperature-dependent stiffness changes. The results showed (Figure 7):

- Glass/glass modules exhibited significantly lower deflection than glass/backsheet modules.
- At 5400 Pa, the average deflection of glass/glass samples was 0.27 mm, compared to 0.64 mm for glass/backsheet samples.
- The combination of glass/glass architecture and POE encapsulant showed the lowest crack susceptibility at low temperatures.

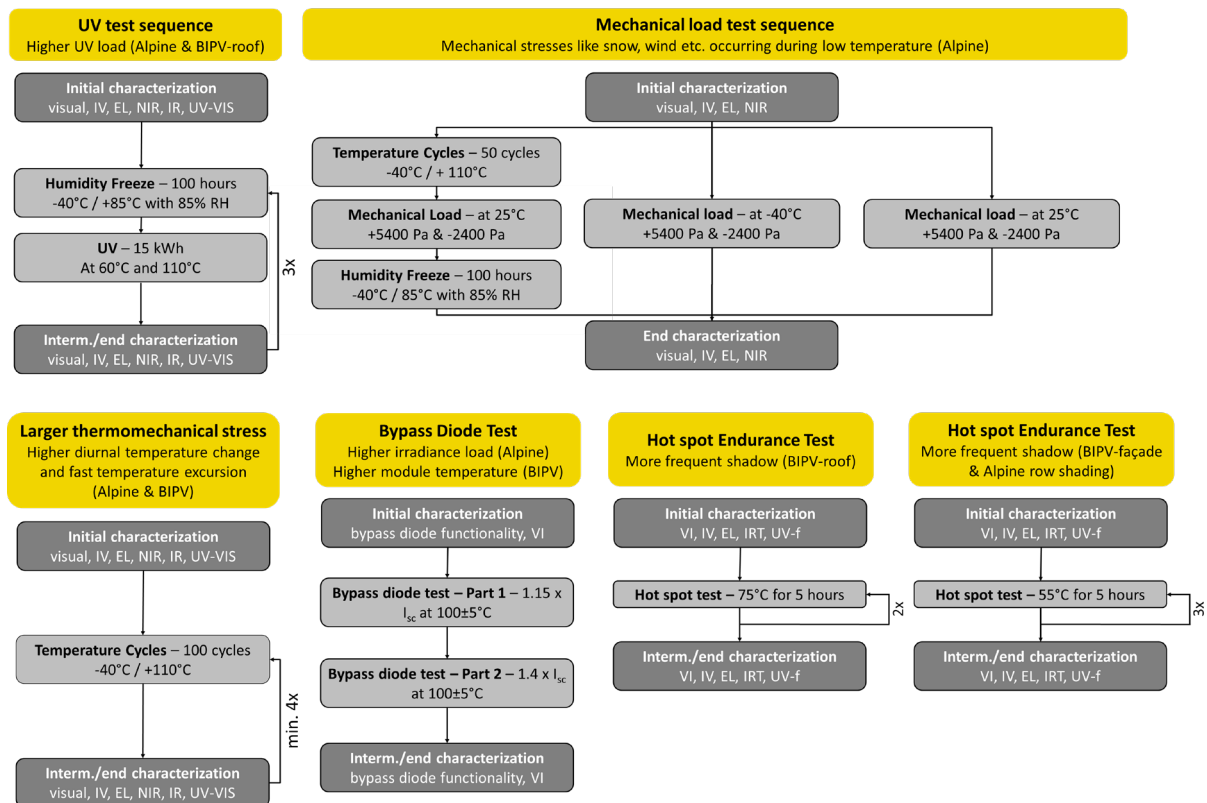
Figure 8: Developed Alpine PV and BIPV Test Sequences. For each test sequence, the aimed PV application is indicated in parentheses.

The mechanical load sequence specifically addresses alpine snow and wind loads. The UV, thermal cycling, hot spot, and bypass diode sequences are relevant for both Alpine PV and BIPV applications due to elevated irradiance, partial shading, and temperature-related stresses. All test campaigns were conducted in the third project year.

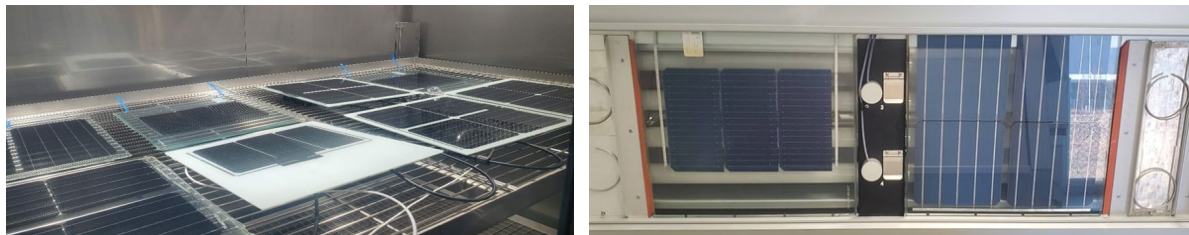
Figure 9: Mini-modules undergoing UV exposure. **(left)** Metal halide irradiation (300–2500 nm) at $\approx 110^{\circ}\text{C}$ module temperature. **(right)** UVA irradiation (300–400 nm, intensified irradiance peak at 340 nm) at $\approx 60^{\circ}\text{C}$ module temperature.

- Backsheet surface degradation was severe, particularly under intensified UVA exposure.
- Backsheet bulk degradation was stronger at higher module temperature (110°C), showing a crystallisation peak shift of $+12^{\circ}\text{C}$ (vs. $+6^{\circ}\text{C}$ at 60°C), **indicating polymer chain scission**.
- POE encapsulant showed no detectable degradation, as it is a very stable material.
- Electrical degradation trends were inconclusive due to sample diversity and limited statistical base. Slightly stronger degradation was observed for TOPCon compared to PERC (V_{oc} and FF losses).

Higher module temperatures significantly accelerated the degradation of module materials. However, the applied UV dose (in total 60 kWh/m^2 , less than a year in relevant environments) was likely insufficient to represent long-term alpine exposure. Extended UV testing is planned in follow-up projects, such as [ALIENCE](#) (alpine) and [COLOUR](#) (BIPV).

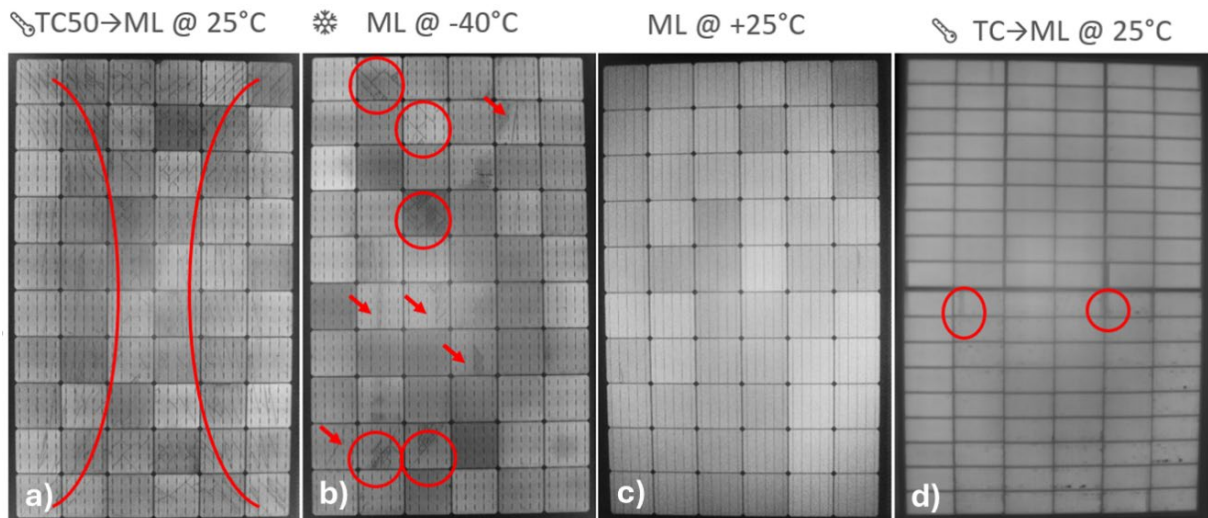
Figure 10: Electroluminescence images of modules **a-c)** with busbars and **d)** with wires after the static mechanical load test under different conditions.

- Glass/glass modules showed no cell cracking, but frameless designs were susceptible to glass breakage under high loads.
- Multi-wire metallisation (TOPCon) reduced crack propagation (Figure 10d) because the smaller wire volume, compared with wide busbars (PERC), applies less stress on the solar cells (Figure 11).
- From a module design perspective, the findings highlight that POE encapsulation, glass/glass structures, framed modules, and multi-wire metallisation provide improved robustness under mechanical load.

Testing under realistic low-temperature conditions induced representative failure modes earlier than standard testing. **Based on EL and power degradation analysis, the effective acceleration factor exceeded three compared to conventional room-temperature load testing.** Detailed outcomes of the mechanical load tests have been published in a [peer-reviewed paper](#) [17].

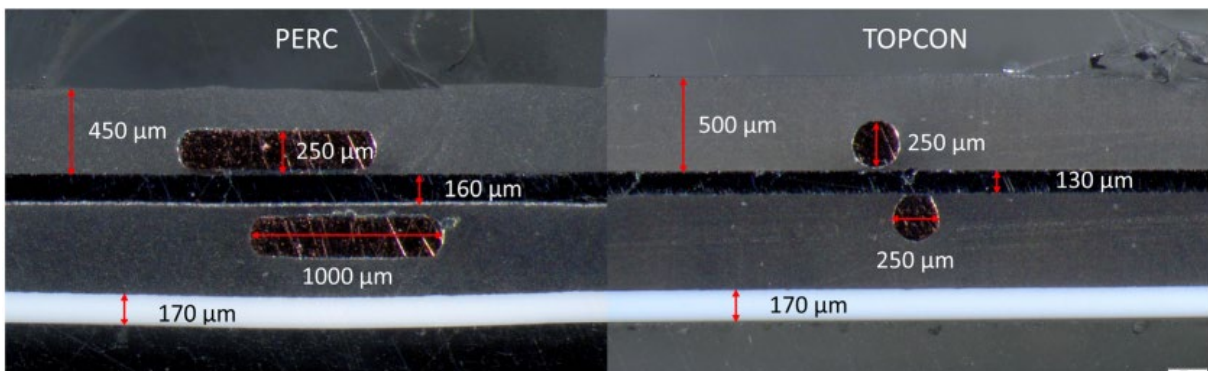
Figure 11: Light microscopic image of cross sections of Glass/Backsheet modules comparing **(left)** PERC cells with busbars and **(right)** TOPCon cells with multi-wires.

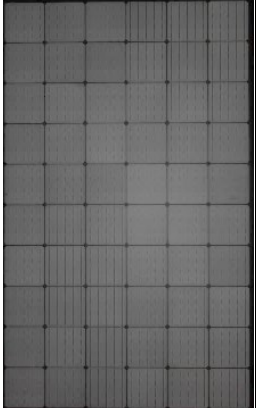
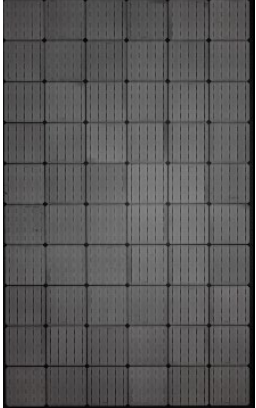
| | Standard TC (-40°C to +85°C) | | Highly Accelerated TC (-40°C to +110°C) | |
| | Initial | 400 cycles | Initial | 400 cycles |

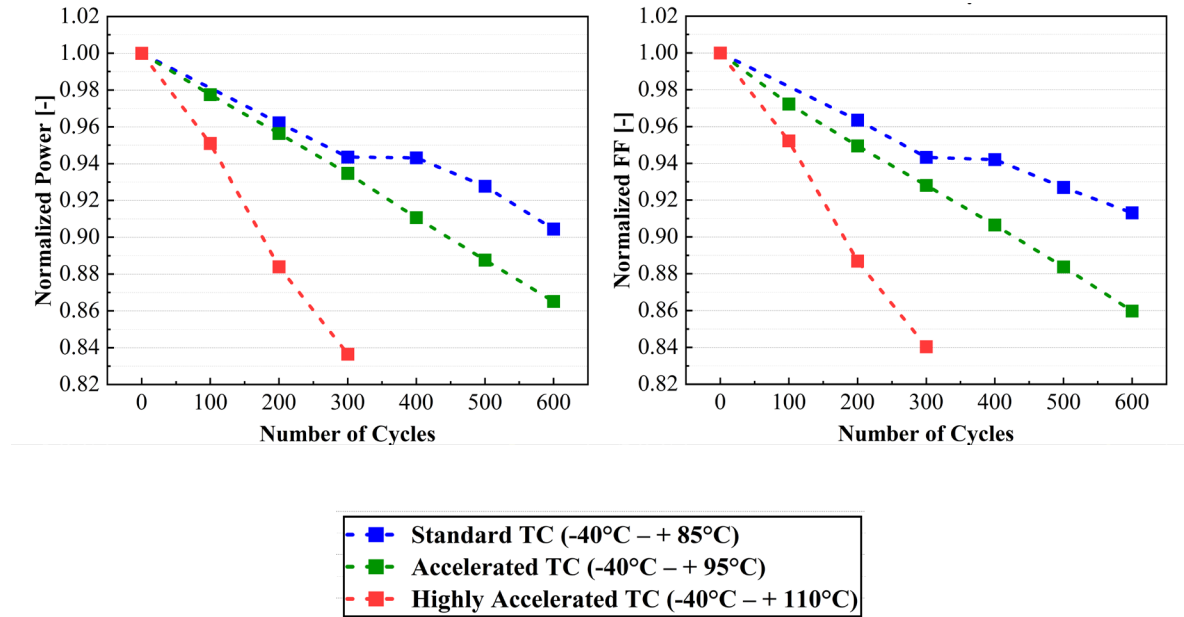
Figure 13: Change in normalized maximum power and fill factor (FF) for G/HJT/BS modules during Standard (-40°C to +85°C), Accelerated (-40°C to +95°C), and Highly Accelerated (-40°C to +110°C) thermal cycling tests.

G/PERC/BS (3.2 mm / BS) and G/IBC/BS (3.2 mm / BS) modules did not show any significant performance changes, so they are not shown here. However, as illustrated in Figure 13, G/HJT/BS modules experienced notable performance degradation due to thermomechanical stresses. All three modules showed damaged fingers (Table 7). When the TC test was performed under more demanding conditions by increasing the maximum temperature, the thermomechanical stress intensified, resulting in a greater amount and severity of the damage. This accelerated the drop in fill factor, leading to a faster decline in maximum power, without causing unexpected failures.

Acceleration was evaluated by using the FF change per cycle. Three of the six module types showed measurable degradation. **The acceleration factors averaged 3.9 times and reached up to 7.4 times, while test duration increased by only 7–20%** (Table 8). The accelerated tests reproduced the same failure modes observed in the standard TC tests without introducing non-representative damage, demonstrating successful and efficient proportional acceleration.

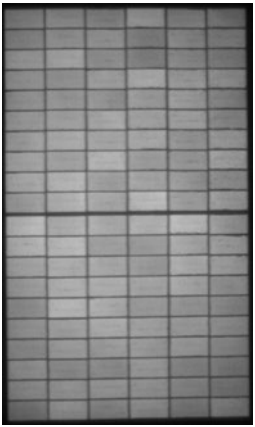
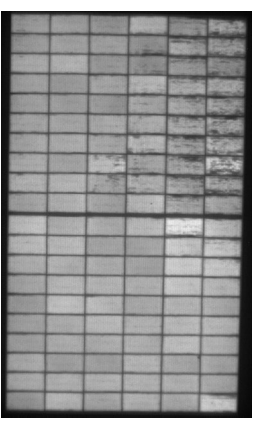
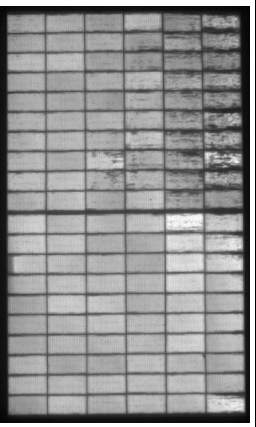
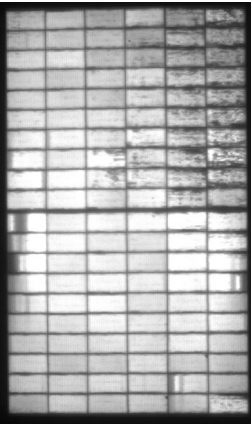
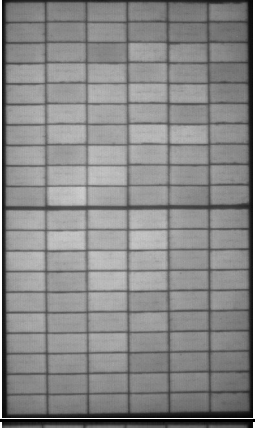
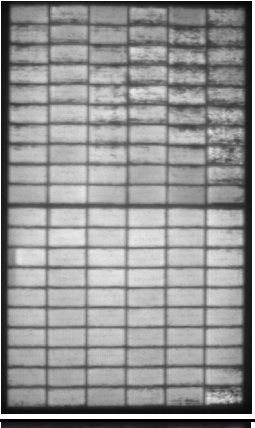
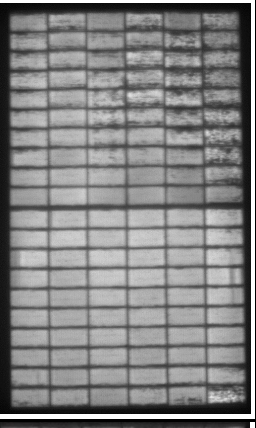
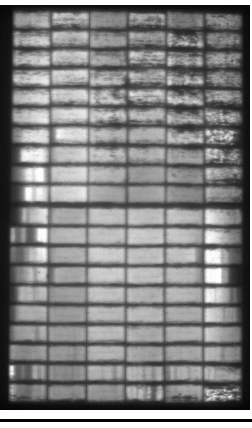
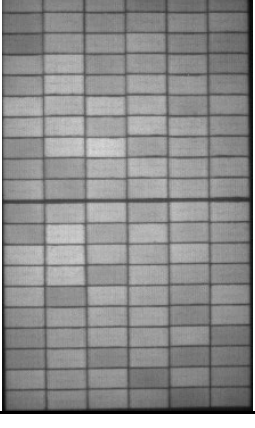
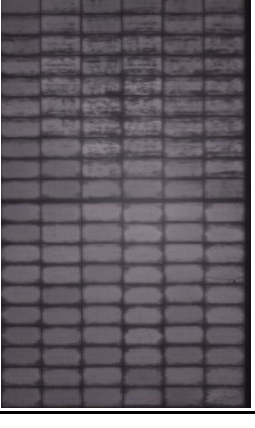
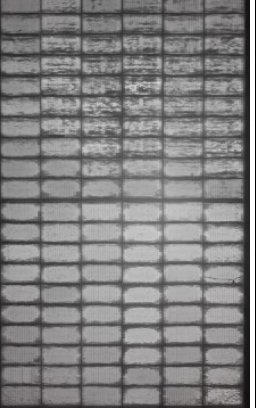
Table 7: Electroluminescence images of G/HJT/BS modules before, and after 200, 300, and 600 cycles of Standard (-40°C to +85°C), Accelerated (-40°C to +95°C), and Highly Accelerated (-40°C to +110°C) thermal cycling tests.

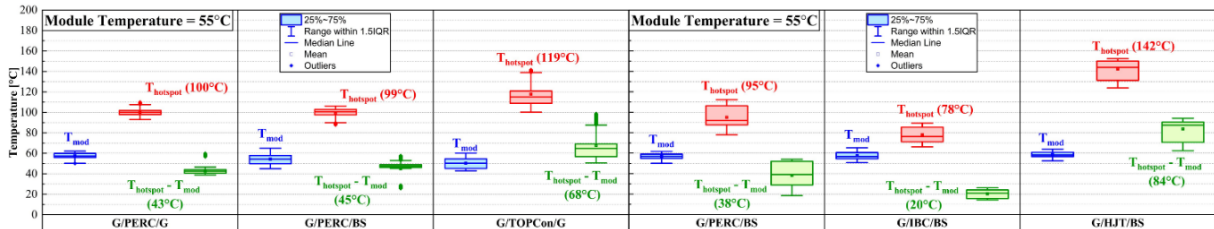
Figure 14: Module temperature (blue), hot spot temperature (red), and their difference (green) recorded during 15 hours of hot spot endurance test conducted at a controlled module temperature of 55°C.

Hot spot tests at standard, 55C, and elevated, 75C, module temperatures (Figure 8) were carried out for up to 15 hours in 5-hour increments on glass/glass and glass/backsheet PERC, HJT, IBC, and TOP-Con modules (Table 4). Figure 14 and Figure 15 present the module and hot spot temperatures. Due to differences in breakdown voltages across the four cell technologies and in BOMs, the modules exhibited different hot spot temperatures. No significant performance losses were observed after testing. Only two modules showed darker regions in the EL images at the hot spot location, indicating localized metallization damage caused by the elevated temperatures.

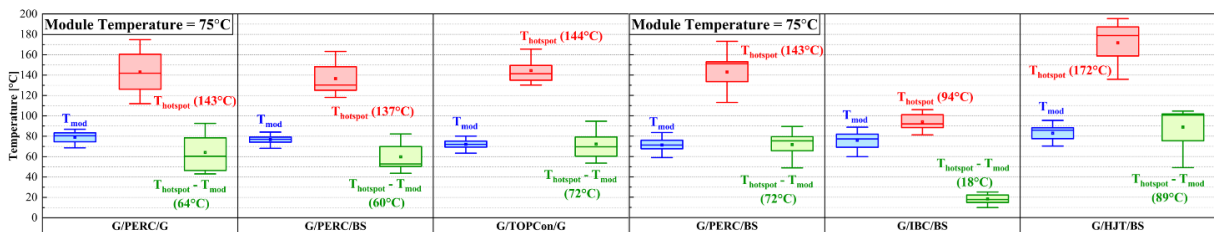
Figure 15: Module temperature (blue), hot spot temperature (red), and their difference (green) recorded during 15 hours of hot spot endurance test conducted at a controlled module temperature of 75°C.

Except for minor signals detected in the non-destructive and destructive material analyses (such as a slight colour change on the backsheet surface or the start of adhesive degradation in the multi-layer backsheet), no significant material-level changes were observed even after 15 hours of testing at a 75°C module temperature.

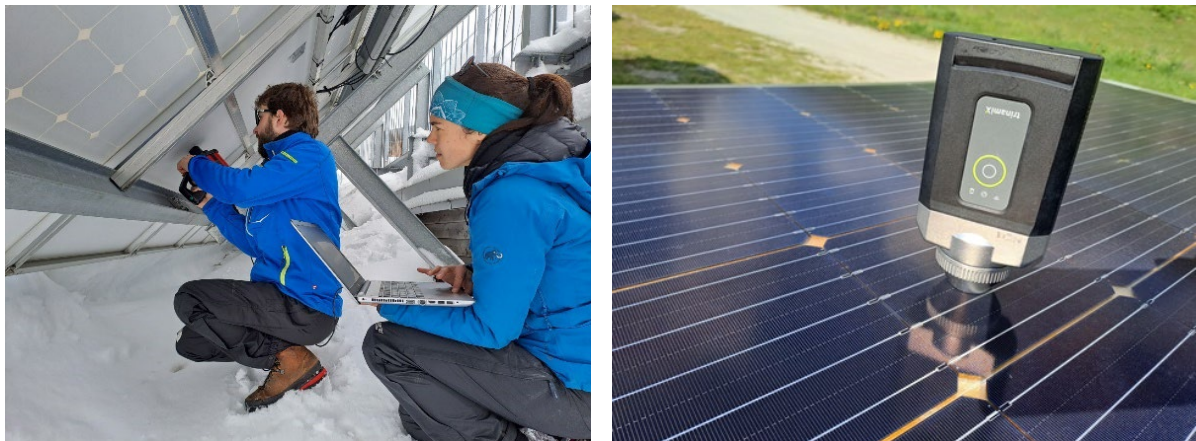
Figure 17: (left) FTIR-measurements of the backsheets of a PV installation at Dobratsch. **(right)** NIR measurement of a module.

Analysis of modules installed in different BIPV configurations showed that these systems are exposed to significantly higher (i) thermal and (ii) thermomechanical stresses, as well as (iii) more frequent shading events compared with modules installed in open-rack PV systems. These stressors can lead to (i) **accelerated photothermal degradation**, (ii) **damage to cells and metallization**, and (iii) defects such as **discolouration, glass damage, and bypass diode failure**.

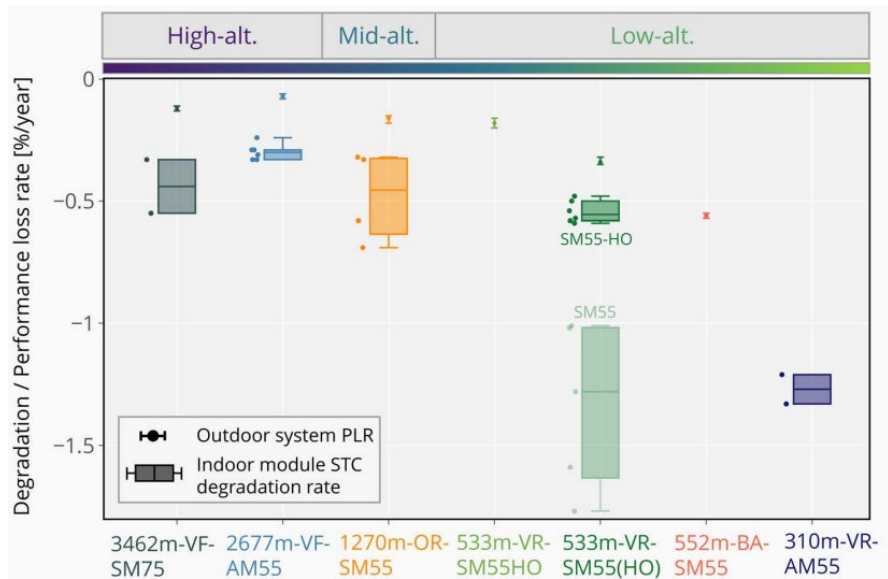
Figure 18: Overview of indoor and outdoor measurement results for all analysed systems in the published work. The figure shows: (i) the module degradation rates of maximum power based on indoor PM measurements (box plots with underlying data points), and (ii) the system PLR calculated from outdoor monitoring data using the multi-YoY method, with 95% CI. Systems are ordered by altitude zones indicated at the top. For the site 533m-VR-SM55(HO), which is composed of 94% SM55-HO modules and 6% SM55 modules, both types are shown for the indoor I-V results. The minority type is displayed in a faded colour for clarity, as it is less representative of the system behaviour.

Analysing the results between high and low altitude systems, PV modules installed at lower altitudes exhibited higher temperatures and correspondingly faster material ageing and performance losses than comparable modules at high-altitude sites (Figure 18). Although all systems showed low annual degradation rates ($< -0.6\%/year$), modules from the high-altitude sites exhibit lower performance losses compared to low-altitude ones. Non-destructive and destructive material analyses indicated that these elevated operating temperatures at low altitude accelerated EVA degradation (increased acetic acid formation), resulting in higher cell and metallization corrosion as well as higher adhesive degradation in the backsheet laminate. In contrast, high-altitude modules, despite higher irradiance and large diurnal temperature changes, experienced lower thermal stress, resulting in slower chemical and mechanical degradation. The results proved that when modules are built to survive the harsher conditions of the alpine climate, the conditions can be favourable for a slower material degradation and therefore also electrical degradation. Still, the bill of materials of the slight variations in the module design had the strongest effect on failures and degradation. The results underscore the strong sensitivity of PV module reliability to local climatic stressors and highlight the need for altitude- and climate-specific module design. The results have been published in a [peer-reviewed paper](#) [19].
