Final report

TISO 35+

Thirty-five years with the TISO-10 PV plant: a statistical analysis of failure modes and their impact on safety and production

Date: 19th November 2018

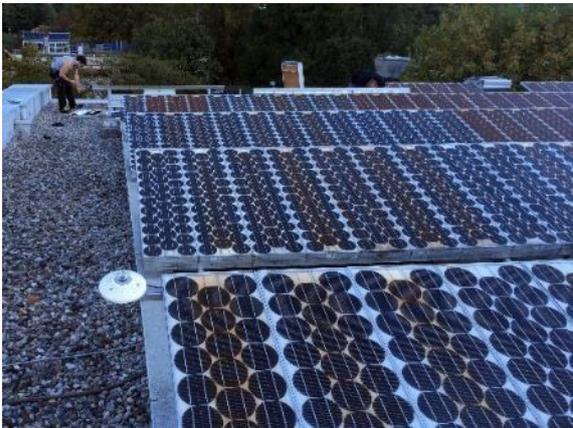
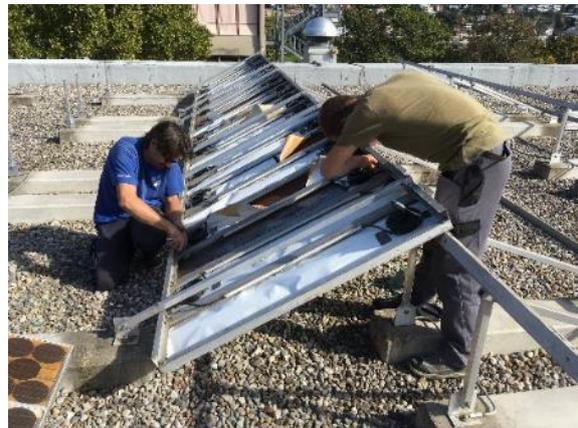
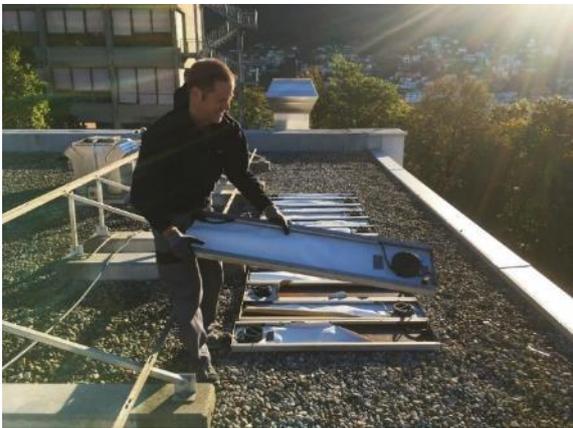
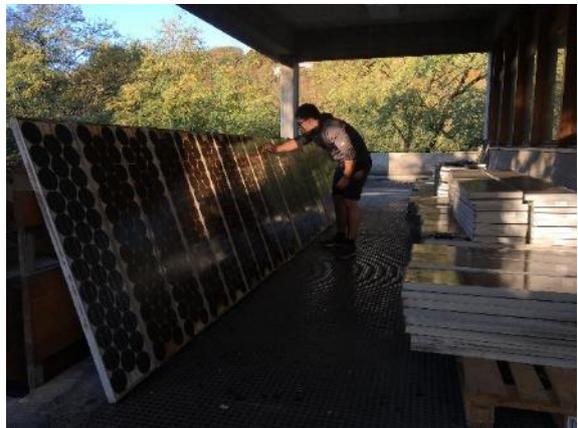
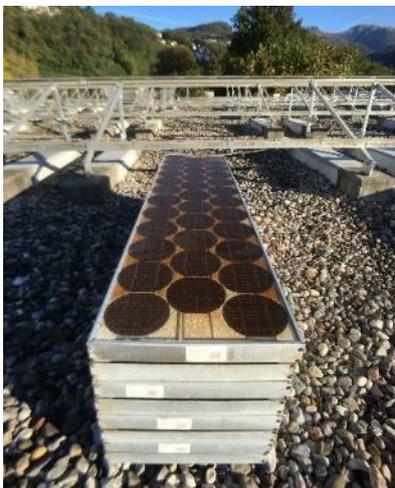
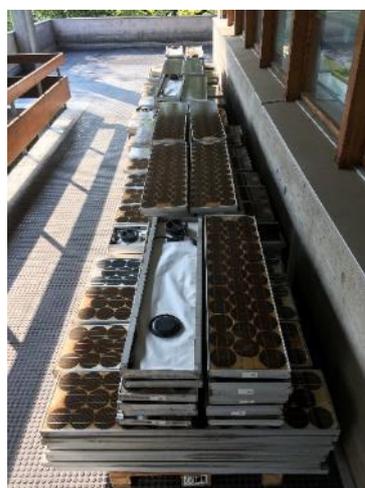
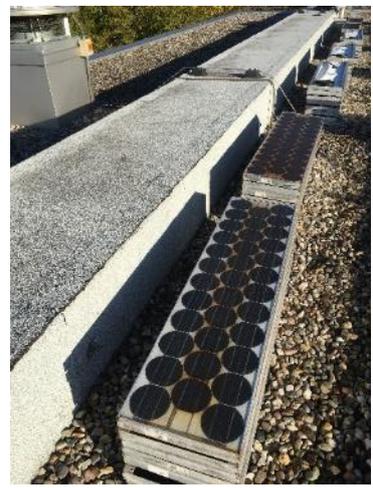
As it can be seen from the pictures, the conditions of the modules were critical for the detachment of the Tedlar back foil and for the severe darkening of most of them. The modules were then placed under a roofed area to grant an easy accessibility to the mobile flasher.

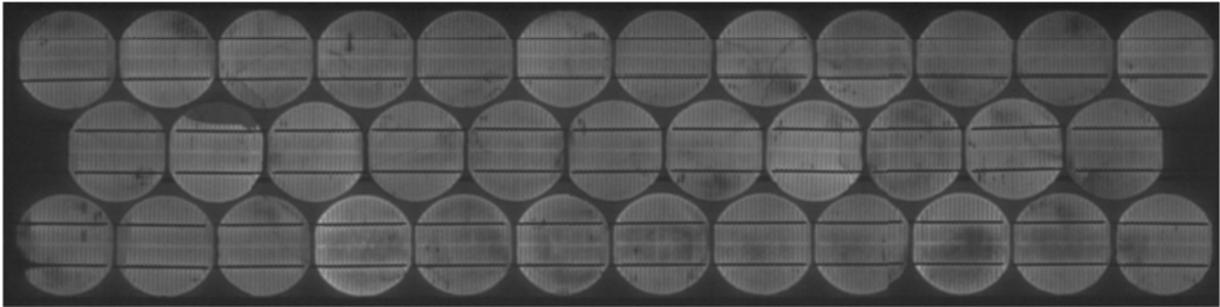
Figure 2: electroluminescence of MBJ's reference module 144185, see following page for electrical results

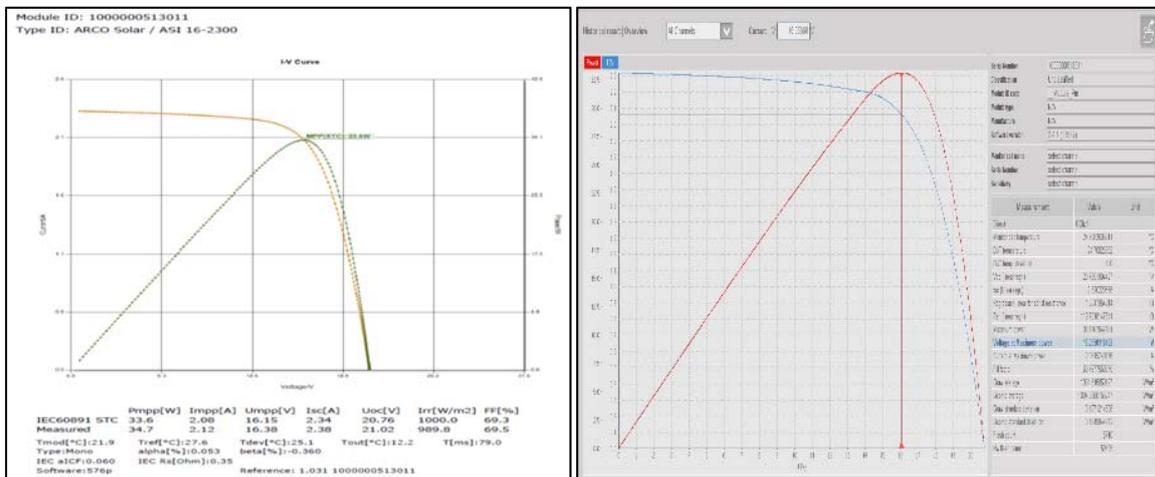
Figure 3: MBJ's reference module S/N 144185: power of 33.6W measured on MBJ (left) versus 33.1W of Pasan IIIb (right), 1.5% difference.

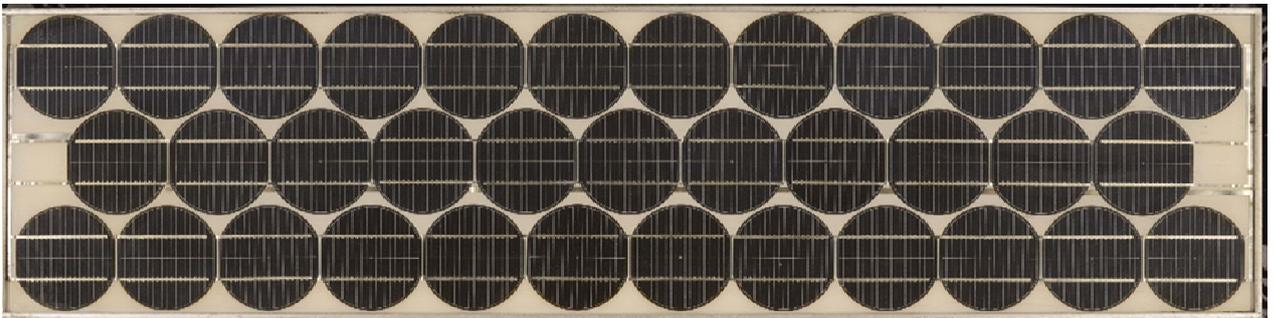
Figure 4: Class A module: clear encapsulant

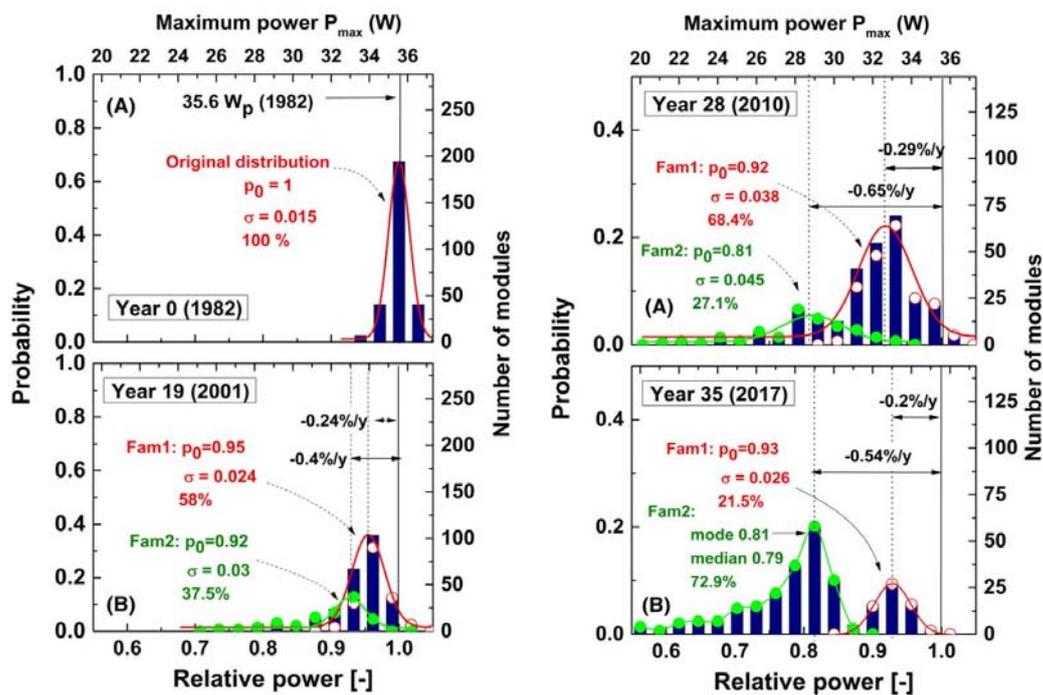
Figure 12: distributions of the power measured during the years on the modules of TISO. 1982: 18 reference modules. 2001, 2010 and 2017: full set of 288 modules.

One Gaussian is relative to a majority of the module's population (group 1, $\sim 58\%$) with a yearly performance degradation rate of $-0.2\%/y$ and the other (group 2, $\sim 37.5\%$ of the total) with a twice as large degradation rate of $-0.4\%/y$. The standard deviation of the two distributions is similar. Thirteen modules (group 3, 4.5% of the total) were not performing any longer ($P = 0$ W) in 2001, a share that increases to 15 modules ($\sim 5.2\%$) in 2017. Generally, these modules have a detached junction box or loss of continuity in the electrical circuitry. The performance measurements of 2010 (after 28 years of operation) are presented in Figure 12 on the right and clearly show that the earlier assumption of having

1. Group 1: 68.4% of the module shows a very modest degradation that is well described by a Gaussian with mean yearly power degradation of $-0.29\%/y$;
2. Group 2: 27.1% of the modules can be described by a similar but broader distribution with a mean yearly degradation rate of $-0.65\%/y$.

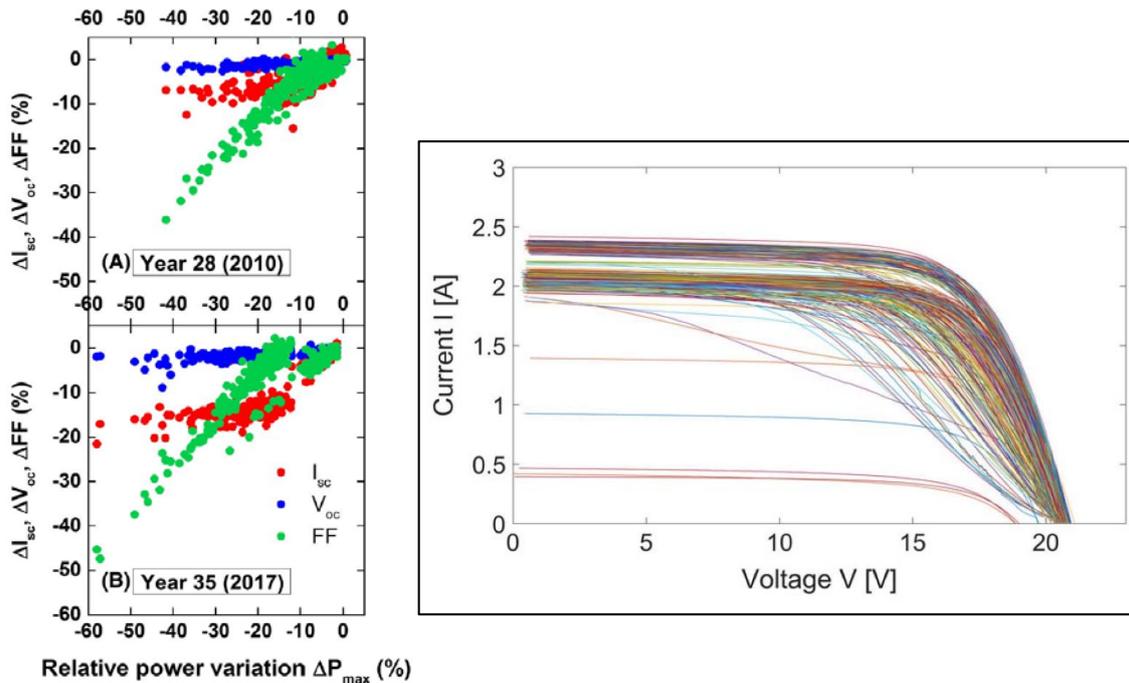
Figure 14: Left: relationship between the variations in P_{max} and the variation in I_{sc} , V_{oc} , and FF for the full set of modules, with respect to the original (1982) PV parameters, for years A, 2010 and B, 2017. Right: IV curves measured in 2017 for the 273 modules still in operation.

In 2010 (after 28 years of operation), power losses can be clearly correlated to reduction in FF. In particular, large losses in P_{max} are mainly related to large losses in FF. No modules are affected by significant V_{oc} reduction, consistent with the fact that no interruption of the electrical circuit can be detected for the modules in operation, nor any potential-induced degradation (PID) was observed. A considerable fraction of the modules, on the other hand, exhibits losses in I_{sc} , which range between -5% and -11%. These modules are mostly affected by severe yellowing, minor delamination, and hotspots. In 2017 (after 35 years), the situation changes considerably and the trend of the relationship between P_{max} losses and FF losses is not proportional anymore. The two families identified in Section 5.2 for 2017 are clearly distinguishable in Figure 14, B. The modules belonging to Family 1 (with an average power degradation of -7%) are mainly represented by the cloud at the right-side of the plot, and experience a combination of moderate losses in FF and I_{sc} . Modules in Family 2, instead, show a more varied behaviour. With respect to 2010, modules with FF variations in the range $-10\% < \Delta FF < 0\%$ may show here P_{max} degradations of up to -27.3%. This shift is due to an increased reduction in I_{sc} with respect to 2010. This effect becomes particularly manifest if we observe the group with power losses between -12% and -17%, for which the degradation in P_{max} can entirely be ascribed to losses in I_{sc} . In Figure 14, on the right, we display the IV curves measured in 2017 for the 273 modules still in operation, where these different groups of modules can be directly distinguished.

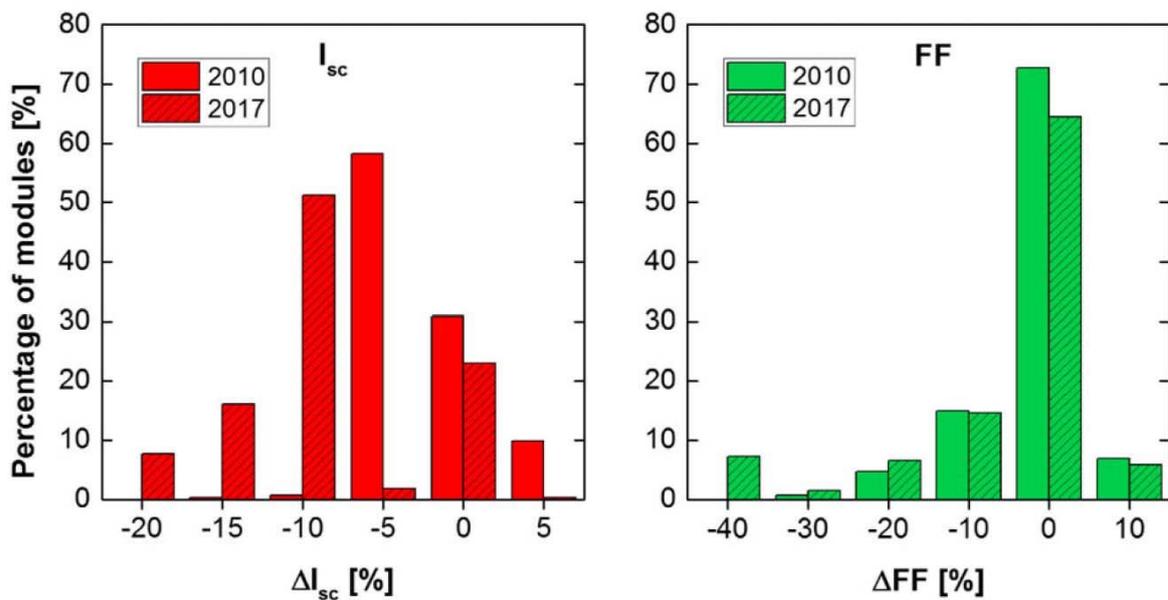
Figure 15 shows the frequency of variations in I_{sc} and FF referred to years 2010 and 2017. In 2010, only 1.1 % of the modules showed I_{sc} losses higher than -10% (with an average of -4.7%), while, in 2017, this share of modules increased to 74.9% (with an average I_{sc} loss of -11 %). Conversely, the frequency of FF losses remains relatively unchanged from 2010 to 2017, with mostly an increase in the percentage of modules having strong FF losses (higher than -40%). A small number of modules results to have positive I_{sc} or FF variations, which we can attribute to uncertainty in the measurements and to the fact that the initial values used to compute the degradation rates refer to the averaged values measured in 1982 for the set of 18 reference modules. The reasons for this evolution in current losses will become clearer in the next paragraph. We suggest, however, that they are correlated to strong browning of the encapsulant, to the presence of hot-spots and cracked cells, and to delamination of the front encapsulant layer. Understandably, some modules are affected simultaneously by multiple failure modes (see Figure 13– right).

Figure 15: Histograms of the variation in I_{sc} and FF in 2010 and 2017 (with respect to the original 1982 PV parameters) with the percentage of modules corresponding to each bin.

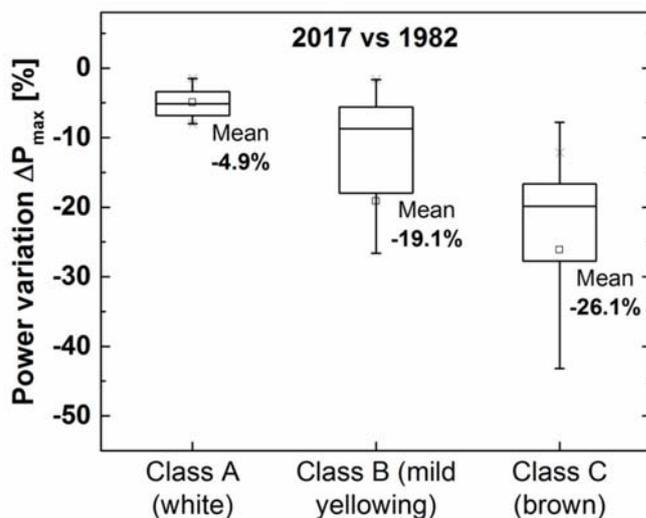
The impact of the discoloration extent is clear in Figure 1, where modules in Class C (uniform browning) show on average the strongest power loss (-26.1% with respect to the initial values). It is remarkable that modules in Class A (for which the encapsulant is still fully transparent) are still performing, in average, at 95.1% of their initial power after 35 years of operation, corresponding to an average degradation rate as small as 0.14%/y.

Figure 16: Power variation (2017 vs 1982) for modules belonging to the three classes defined based on the different level of encapsulant discoloration. The two regions in the boxes depict the first and third quartile, with the internal line indicating the median. For each box, the mean value is reported, and represented as a small square inside the box.

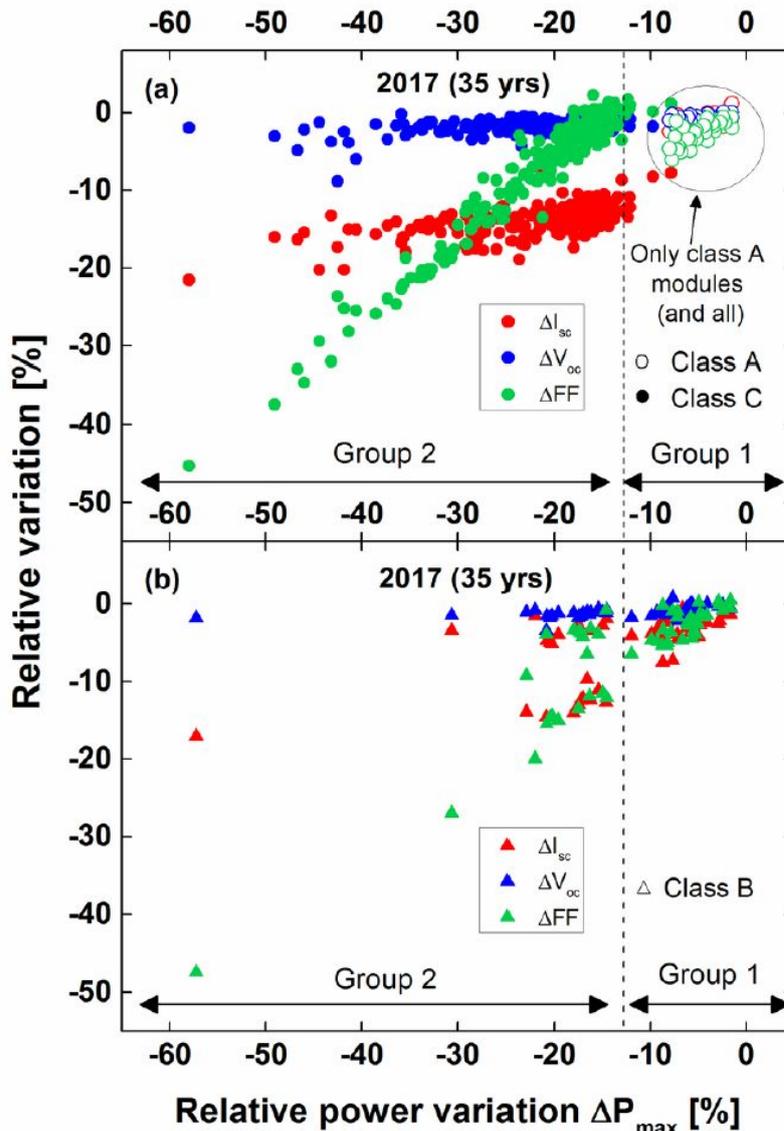
Figure 17: Relative variation of power (2017 vs 1982) for the full set of 288 modules and correlation to losses in V_{oc} , FF, and I_{sc} . a) Open circles represent Class A modules (still transparent encapsulant), full circles: are for Class C modules (browning or uniform yellowing). b) Class B modules (localized and mild yellowing). The vertical dashed line, at $\Delta P = -12.8\%$, indicates the separation between the two groups.

Consistently with what discussed in the previous paragraph, we distinguish the two groups, Group 1 and Group 2, corresponding to the two sets of modules that experienced a mean power degradation of 0.20%/y and 0.69%/y, respectively. The dividing line between the two groups is at -12.8% of relative power variation (dashed line in the plot). Even if the number of modules belonging to the three classes is considerably different, it strikes to observe in Figure 17 a) that 100% of Class A modules (fully transparent encapsulant) belong to Group 1, as it could also be inferred from Figure 15. Interestingly, indeed, modules belonging to Class A show extremely moderate losses in FF as well (and not only in I_{sc}), suggesting that the electrical circuit is not affected by corrosion nor increased series resistances.

The clear demarcation line for the two classes reflects the remarkable reduction in I_{sc} for all modules belonging to Class C. For modules in Class C, different root causes lead to loss in performance. For a sub-set of devices, the power loss can be attributed exclusively to a reduction in current, due to encapsulant browning (power degradations between 12% and 18%). For another sub-set of modules belonging to this class, a reduction in FF is clearly superimposed to the loss in I_{sc} , indicating that these modules are affected not only by encapsulant browning but also, most likely, by problems in the interconnections or hot spots. Modules falling into this category are described in paragraph 0. In Figure 17 we show the intermediate case of Class B modules (with localized and mild yellowing). Here, the power losses are (with the exception of an outlier) limited to 26.6% (i.e. 0.76%/y). As we can see, the power losses span the full range so that Class B modules belong both to Group 1 and to the portion of Group 2 members experiencing the least degradation. In addition, the relationship between the electrical parameters is more varied for this class: in some of the devices the P_{\max} degradation is dominated by a loss in I_{sc} , while others mainly degraded because of a loss in FF. Furthermore, we note that none of the 288 modules experienced significant reductions in V_{oc} , consistently with the fact that no module showed interruption of the electrical circuit nor any sign of potential-induced degradation (PID). To summarize the relationship between the three discoloration classes and the long-term performance degradation rates after 35 years in the field, we report in Table 5 the composition of the two groups presented previously. As we can see, Group 1 (mean power degradation of only 0.20%/y) is mainly composed by modules in Classes A and B, with only a few number of modules from Class C. Group 2, instead, does not contain any module of Class A, and a high fraction of the group is given by modules of Class C (88.3% of the modules in Group 2).

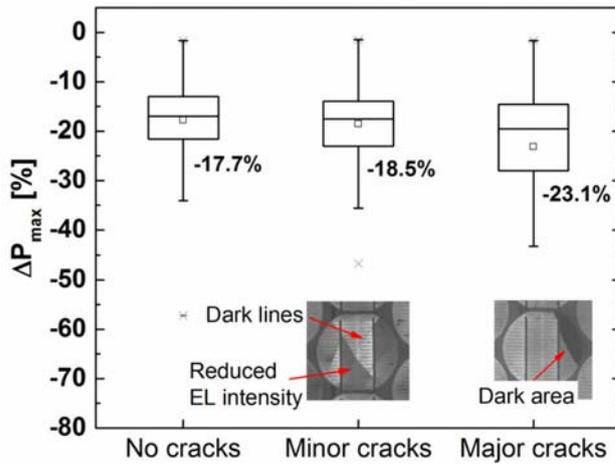
Figure 22: Box plot showing the relative power variation after 35 years for modules containing cells with major cracks, modules with only minor cracks, and modules with no cell cracks. The two regions in the boxes depict the first and third quartile, with the internal line indicating the median; the small square (and the number) denotes the mean value.

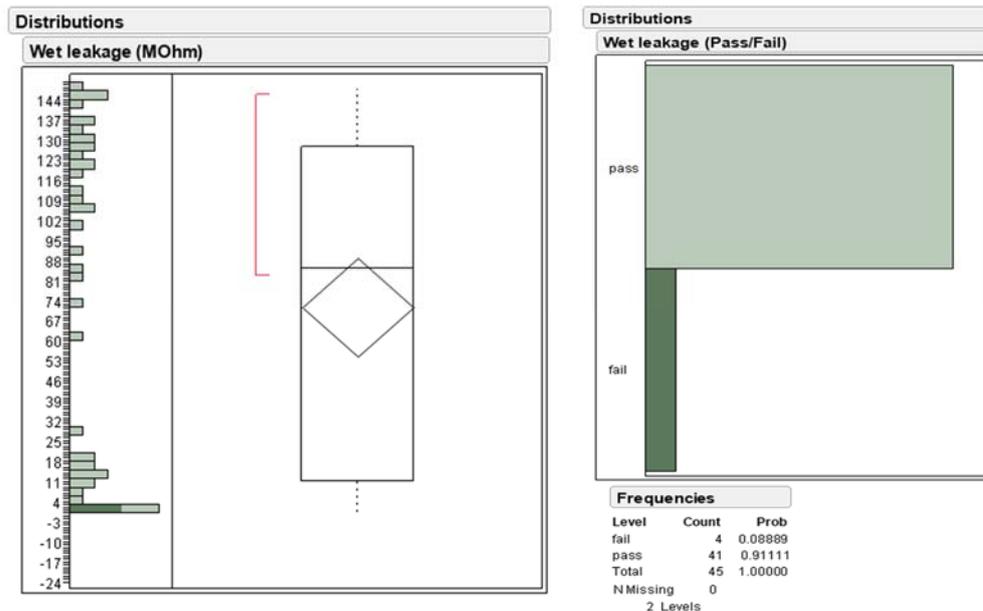
insulation test (all modules belonging to Class A and the best performing modules in Class B). Only 2 of the 43 modules failed the test (see Figure 30 below). A more complete statistic on WL performance is available for year 2010 – after 28 years of exposure – when the full set of modules was subjected to testing. The occurrence of hot spots is also reported in Table 6, even though we point out that hot spots might not be as dangerous for modules with a metal-sheet containing backsheets as for modules packaged with a conventional polymer backsheet.

Figure 30: Results of wet leakage test: on the left the distribution of insulation resistance in MOhm is reported, on the right the Pass/Fail results according to the IEC requirements. On a total number of 43 tests (2 modules were tested twice because of interconnection problems), 2 failed.
